Coastal Hazards and Adaptation in Pacifica, CA

**Pacifica Library, Pacifica, California USA
August 16, 2010**

Bob Battalio, PE, Principal, PWA

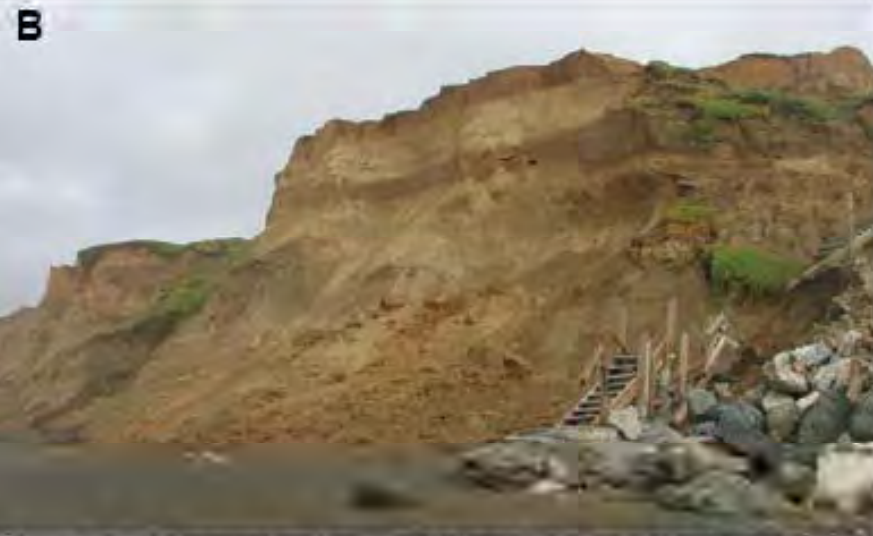
Figure 4. Schematic diagram (A) and photo (B) of weakly cemented coastal cliff failure mode. The failure surface is typically inclined at 65° to the horizontal.

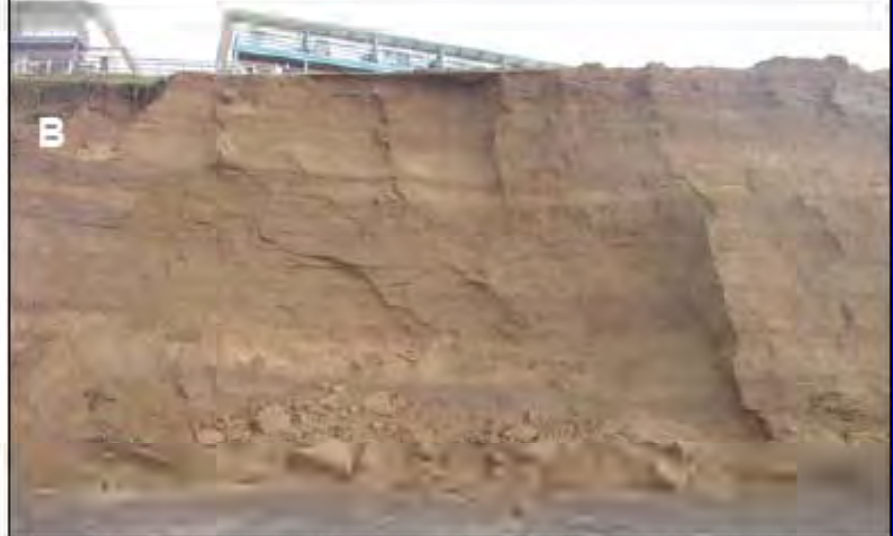
Figure 5. Schematic diagram (A) and photo (B) of moderately cemented coastal cliff failure mode. The failure surface is typically near-vertical.

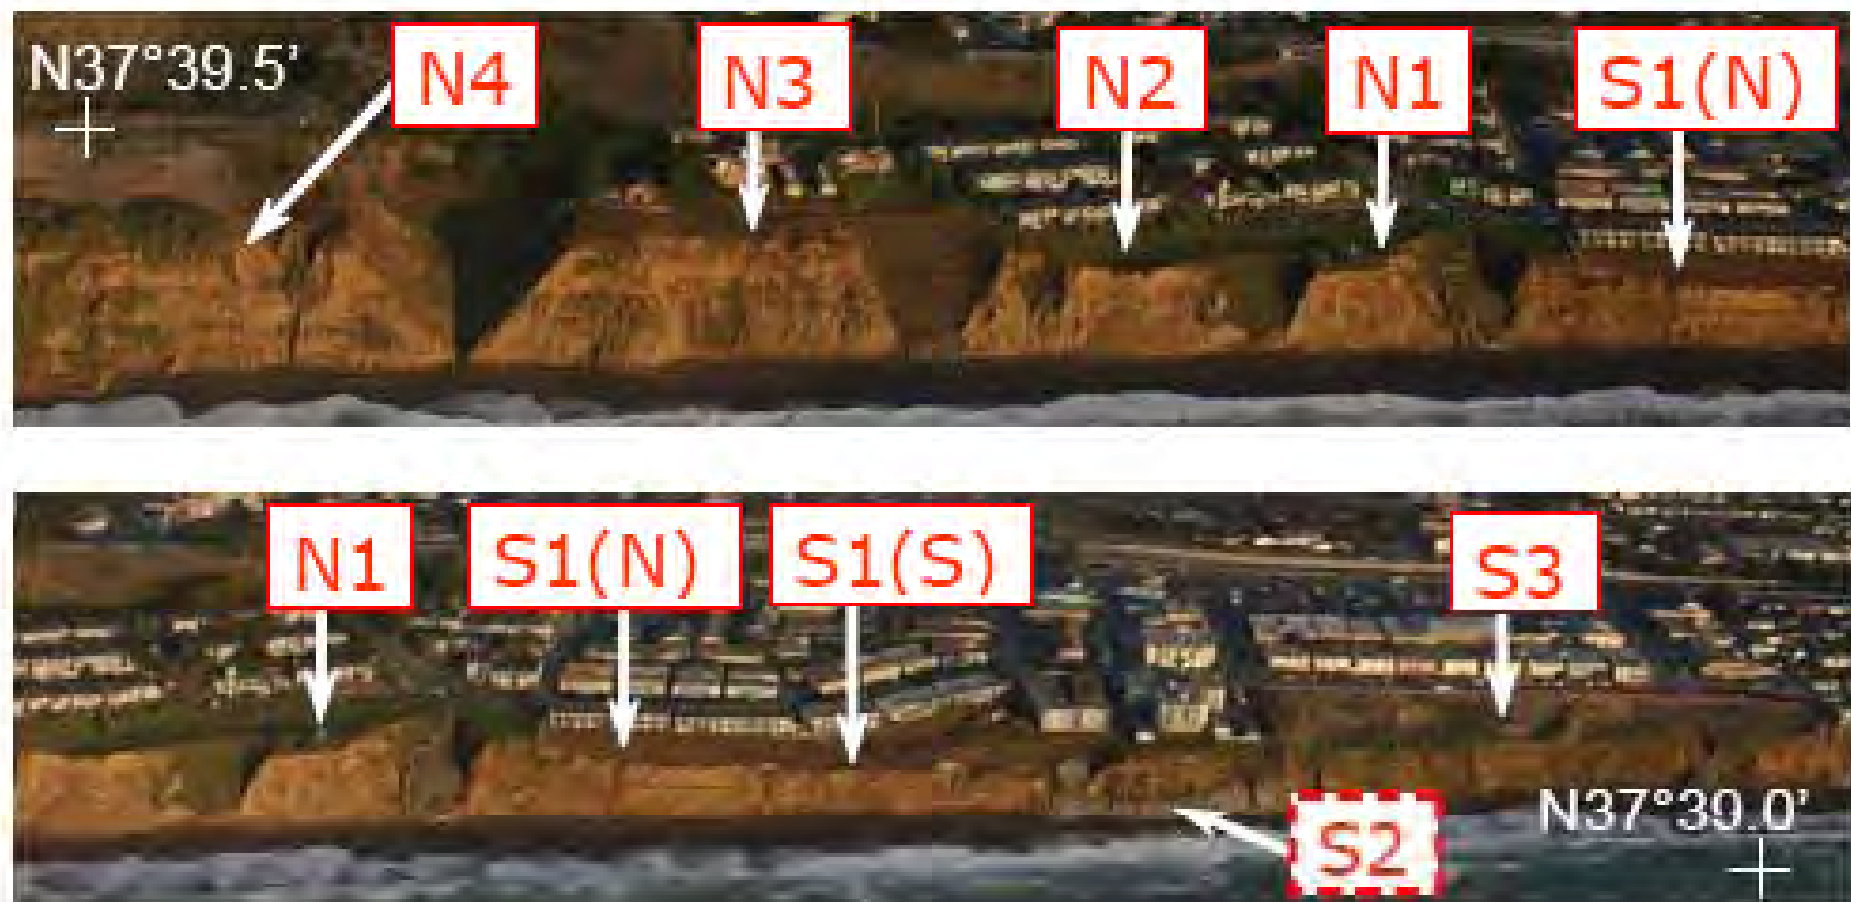
Figure 3. Oblique view of the Pacifica study area showing locations of observed cliffs. Cliff S2 was not observed for failures. Photo courtesy of the California Coastal Records Project.

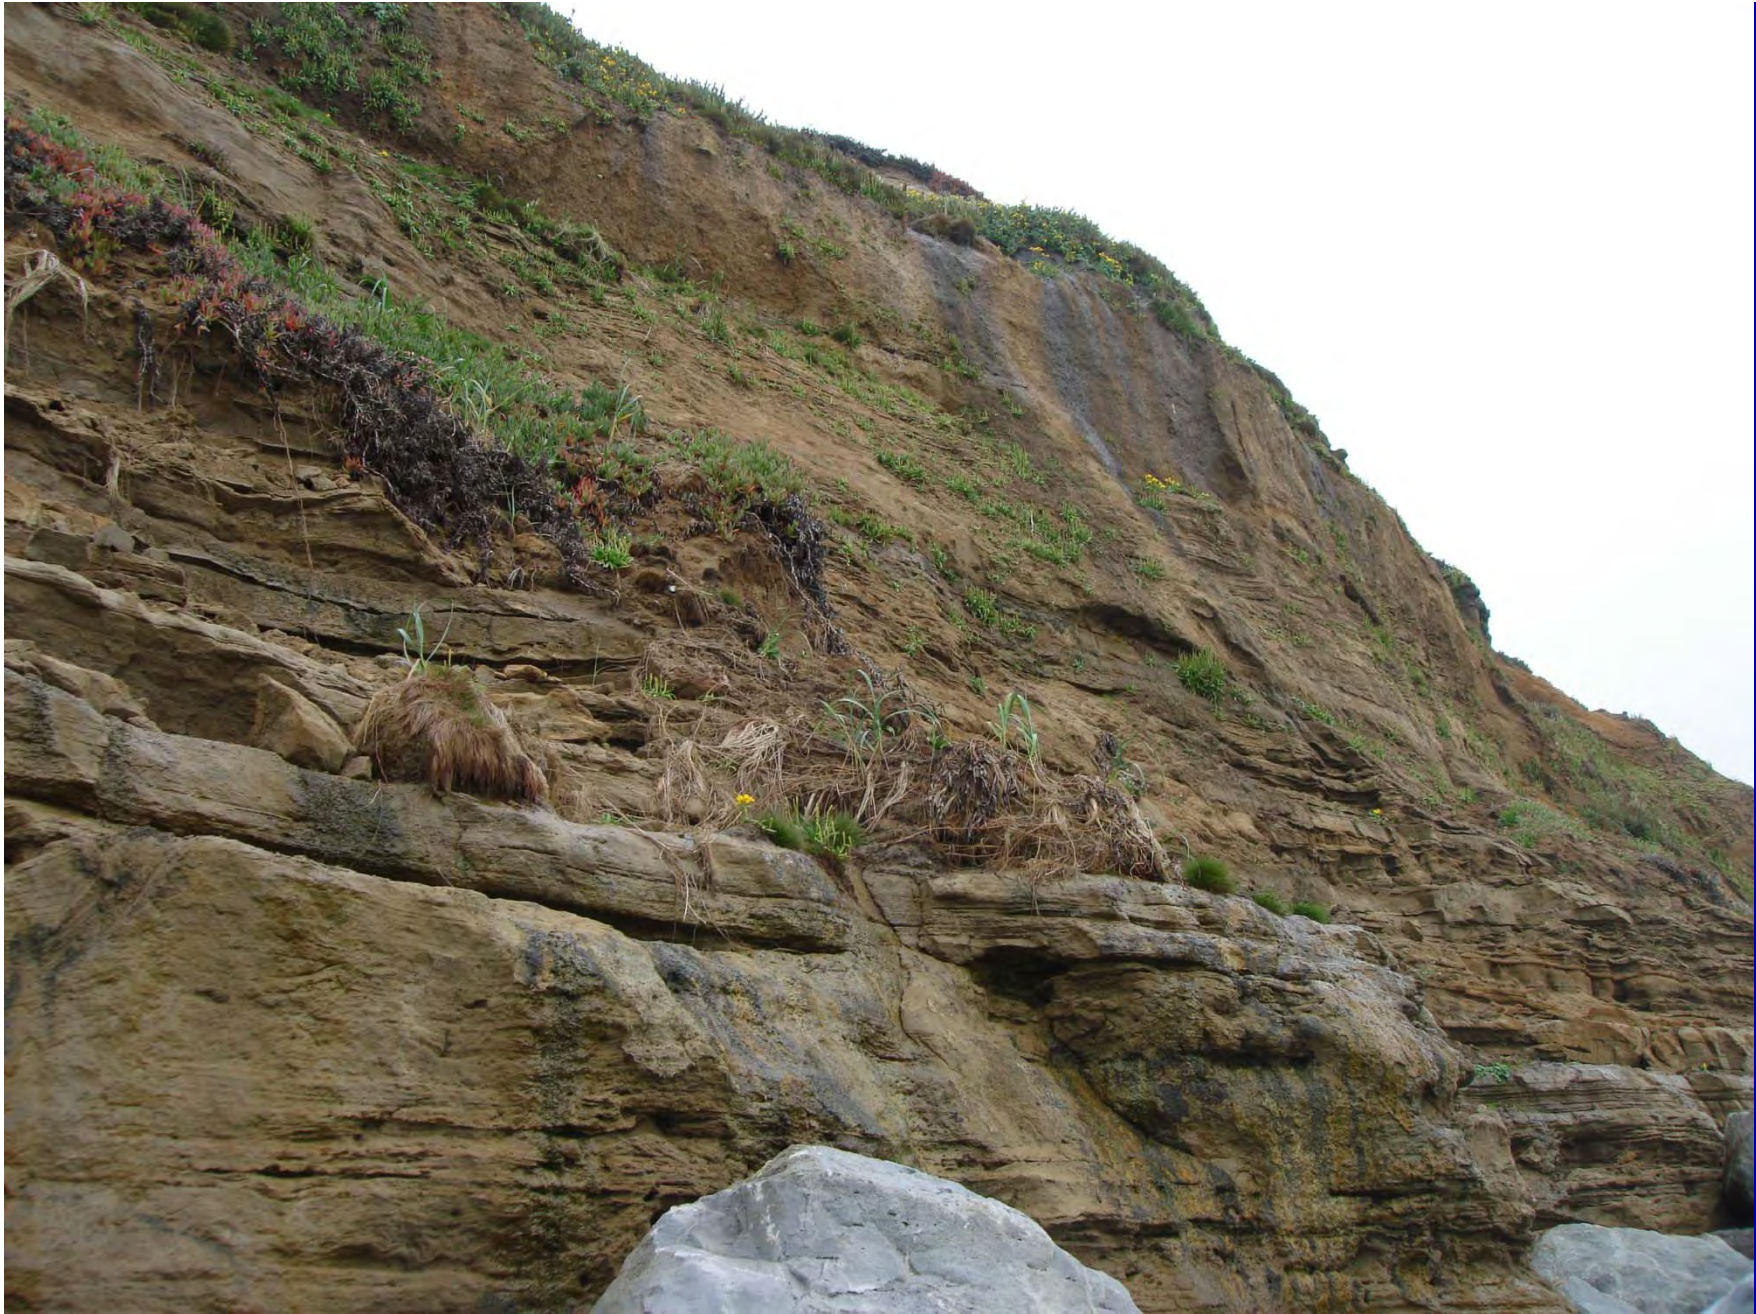
Layers and seeps; Manor Bluffs, Pacifica Aug 2010 © Bob Battalio, 2010

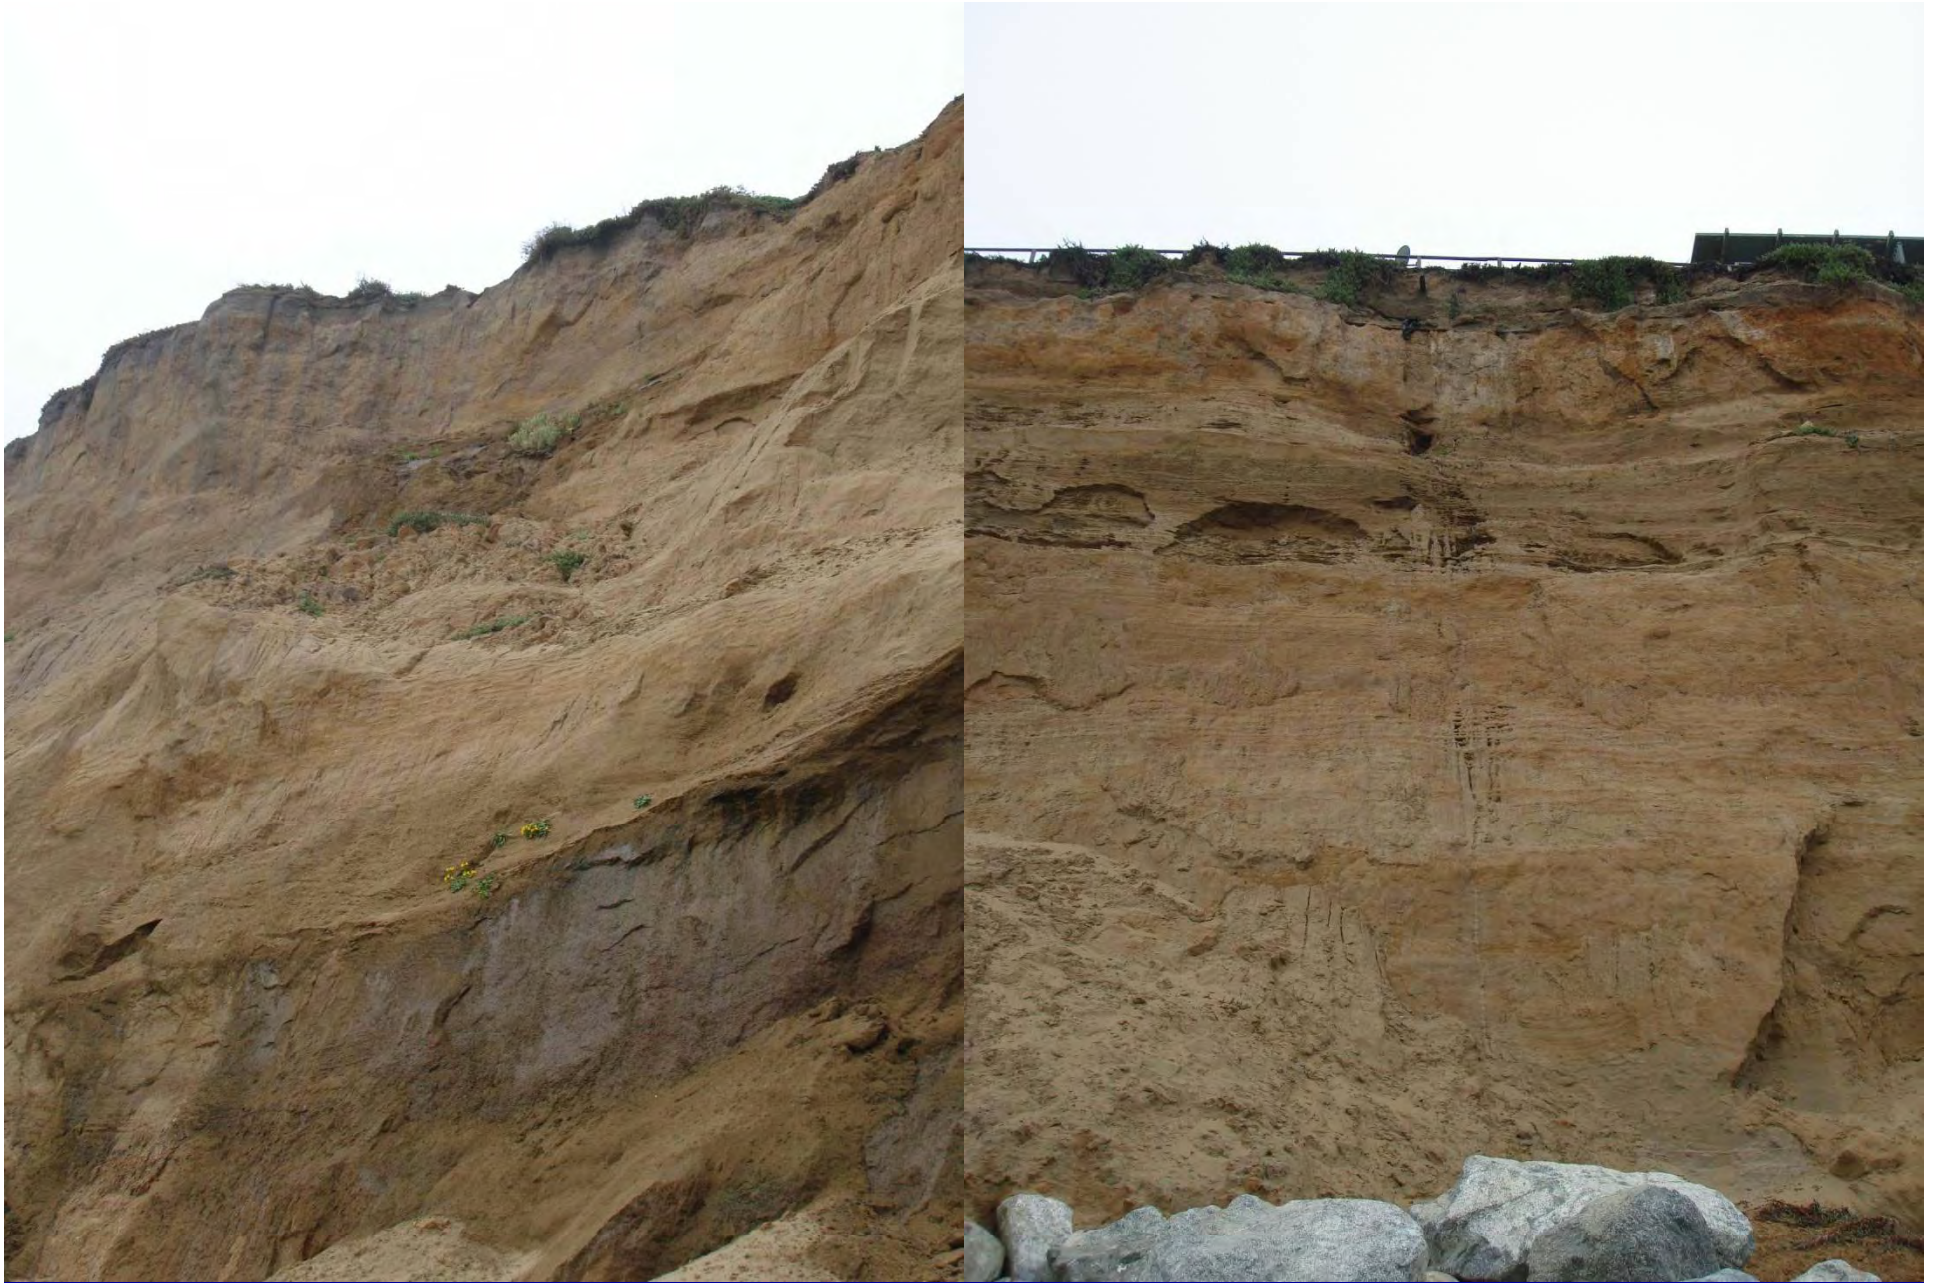
Seeps, rills and piping; Manor Bluffs, Pacifica Aug 2010 © Bob Battalio, 2010

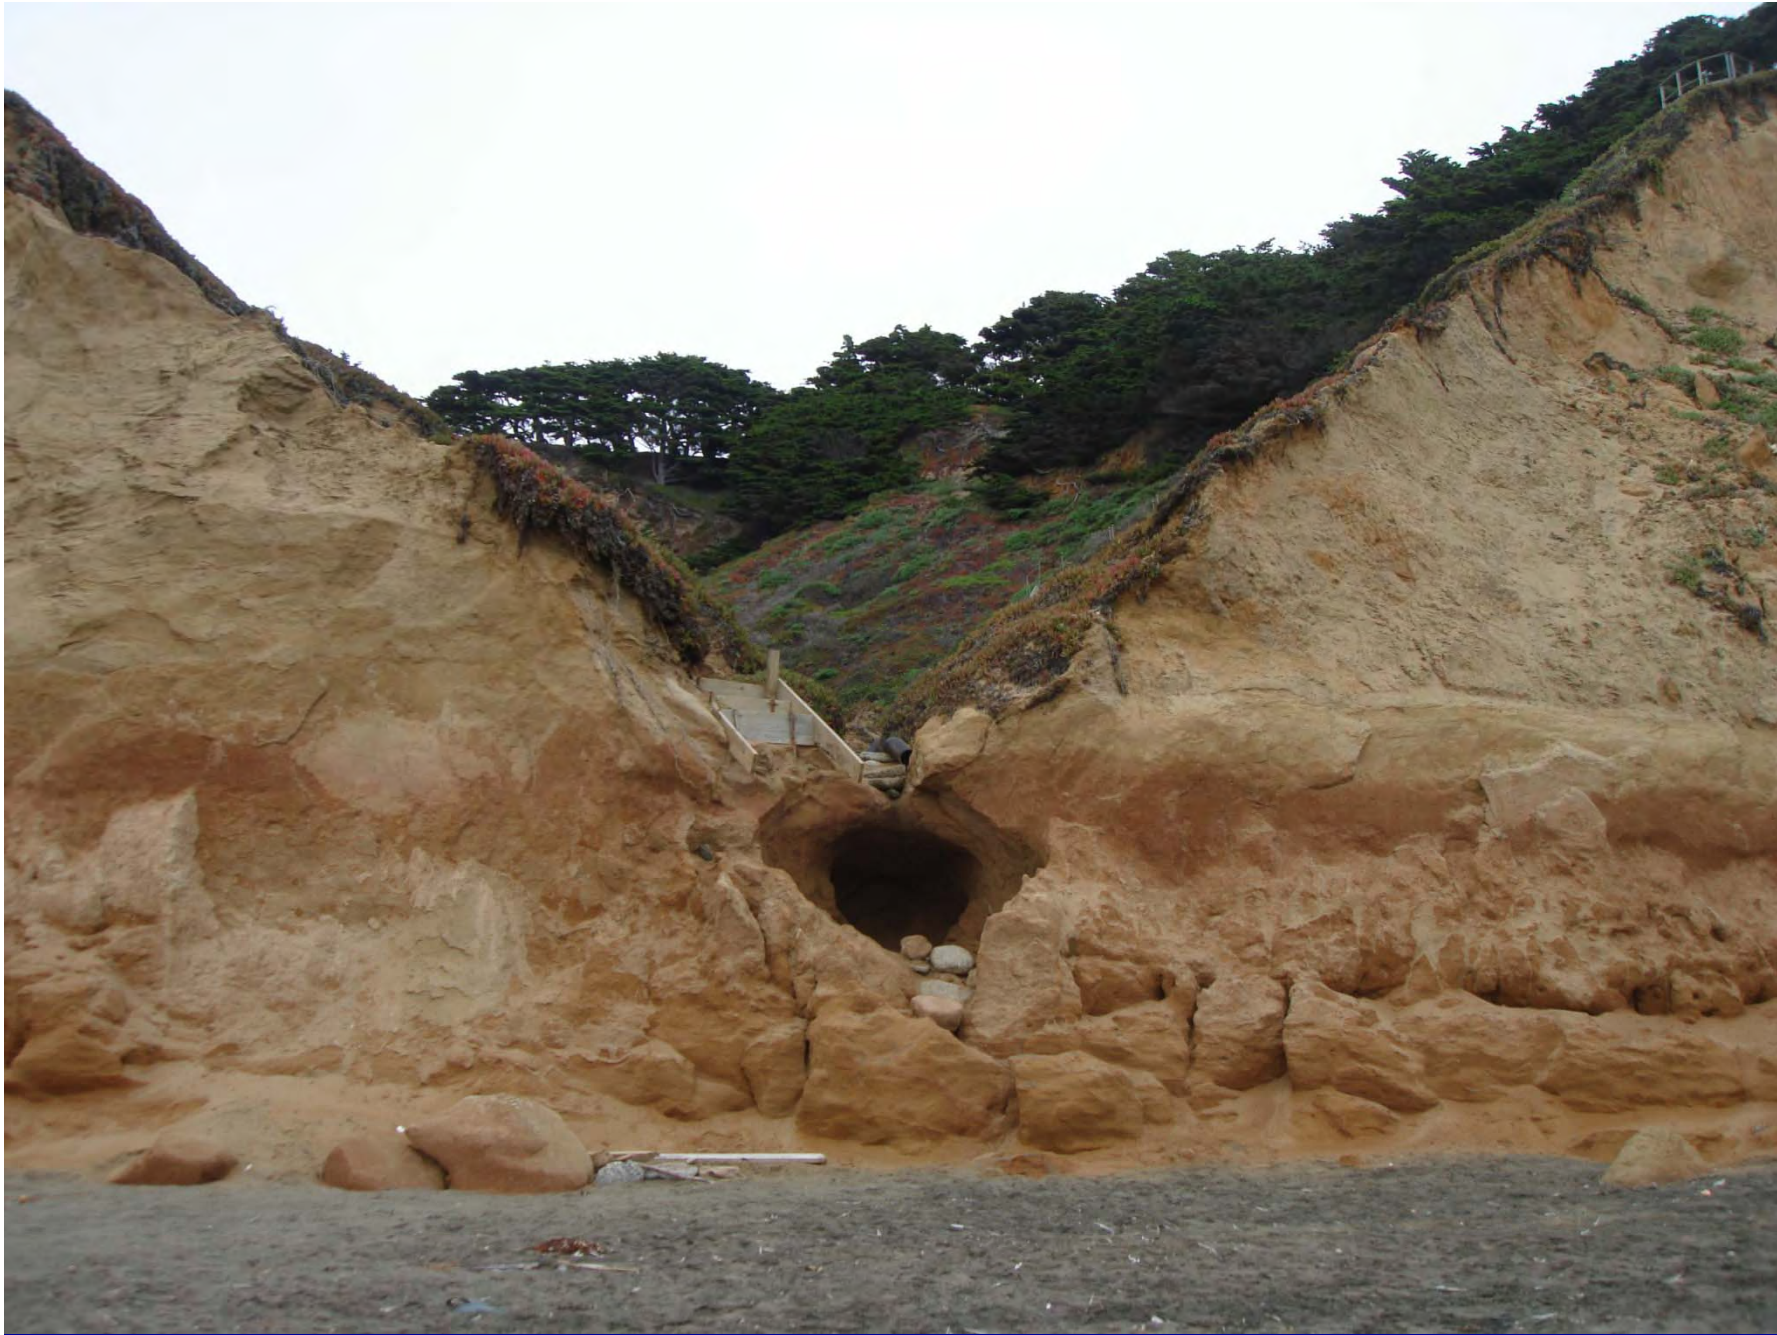
Piping ! Manor Bluffs, Pacifica Aug 2010 © Bob Battalio, 2010

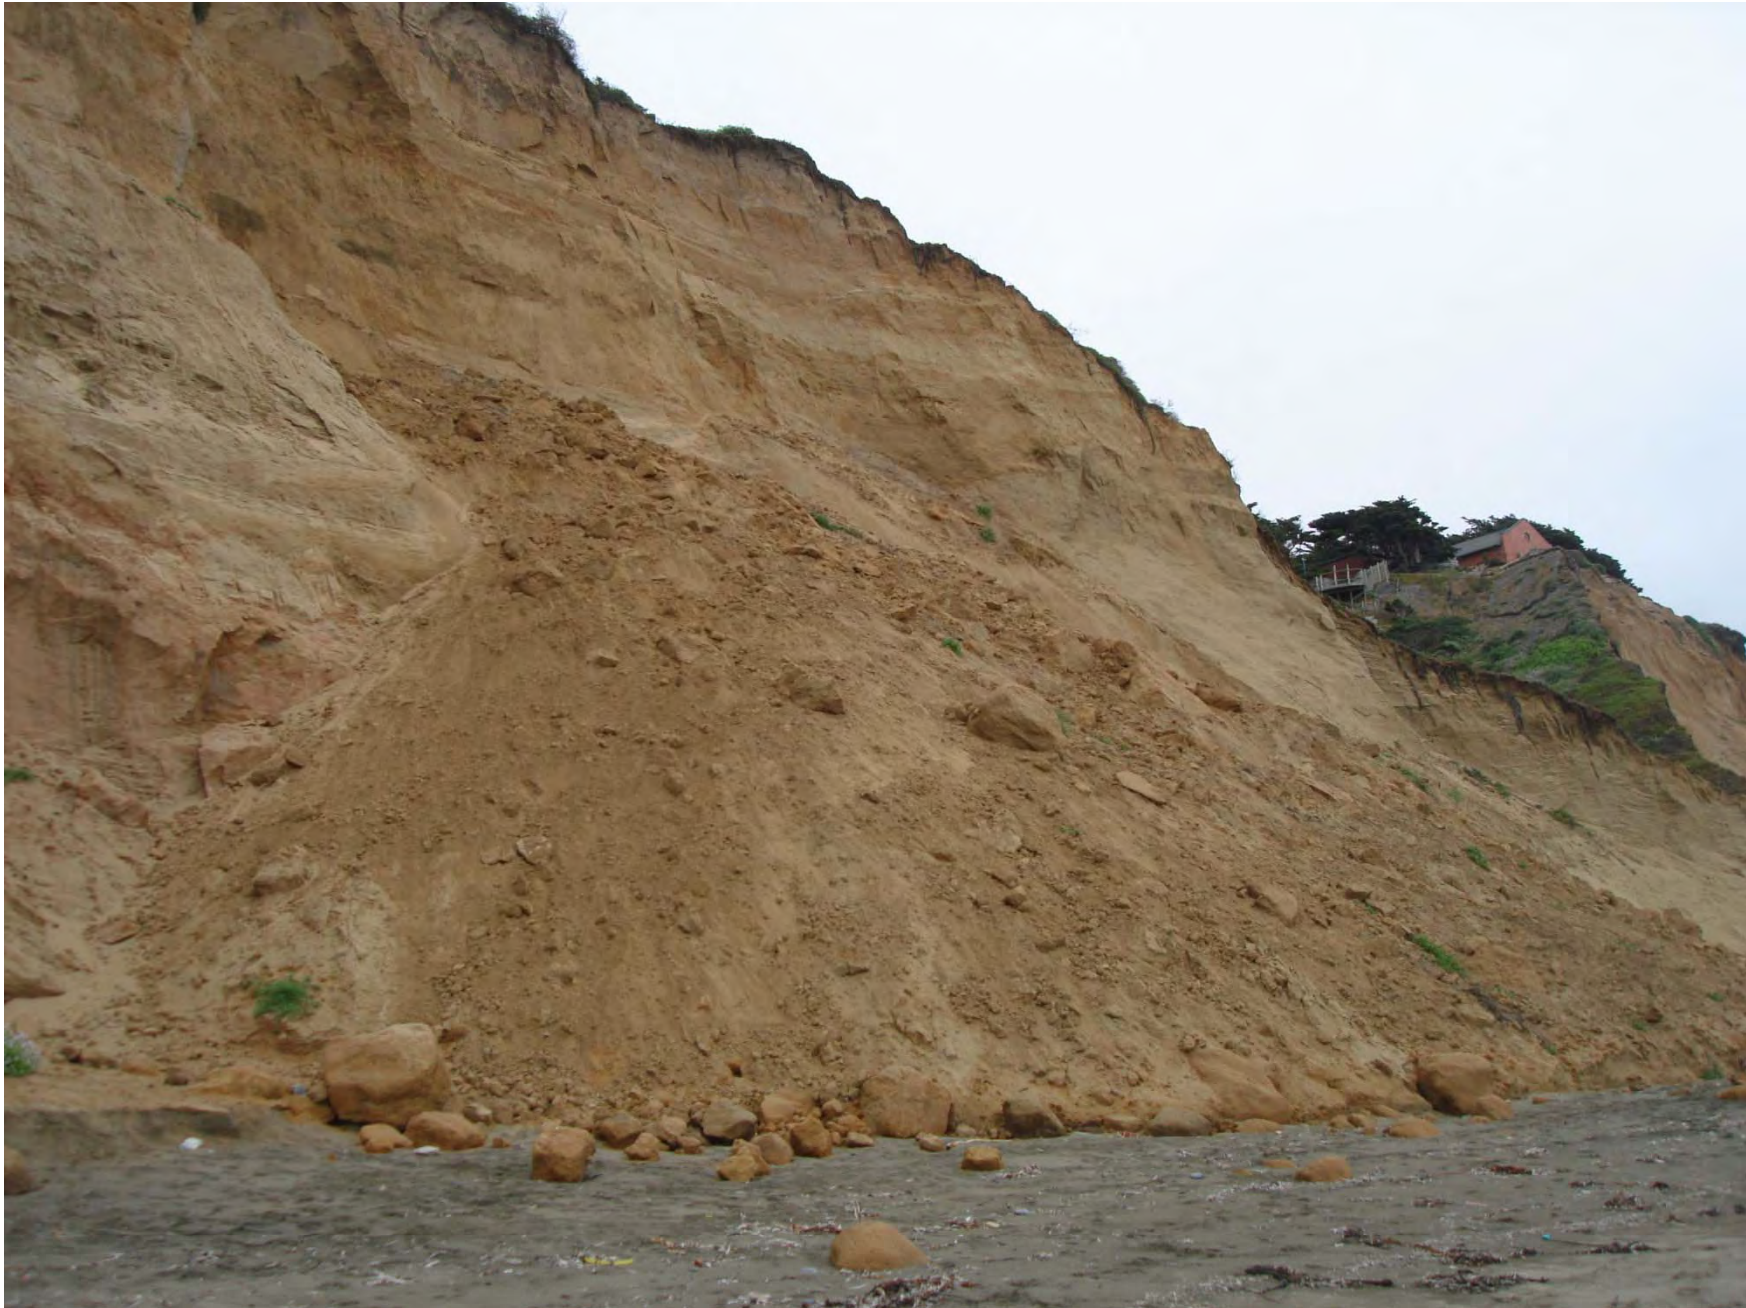
Talus cone; Manor Bluffs, Pacifica Aug 2010 © Bob Battalio, 2010

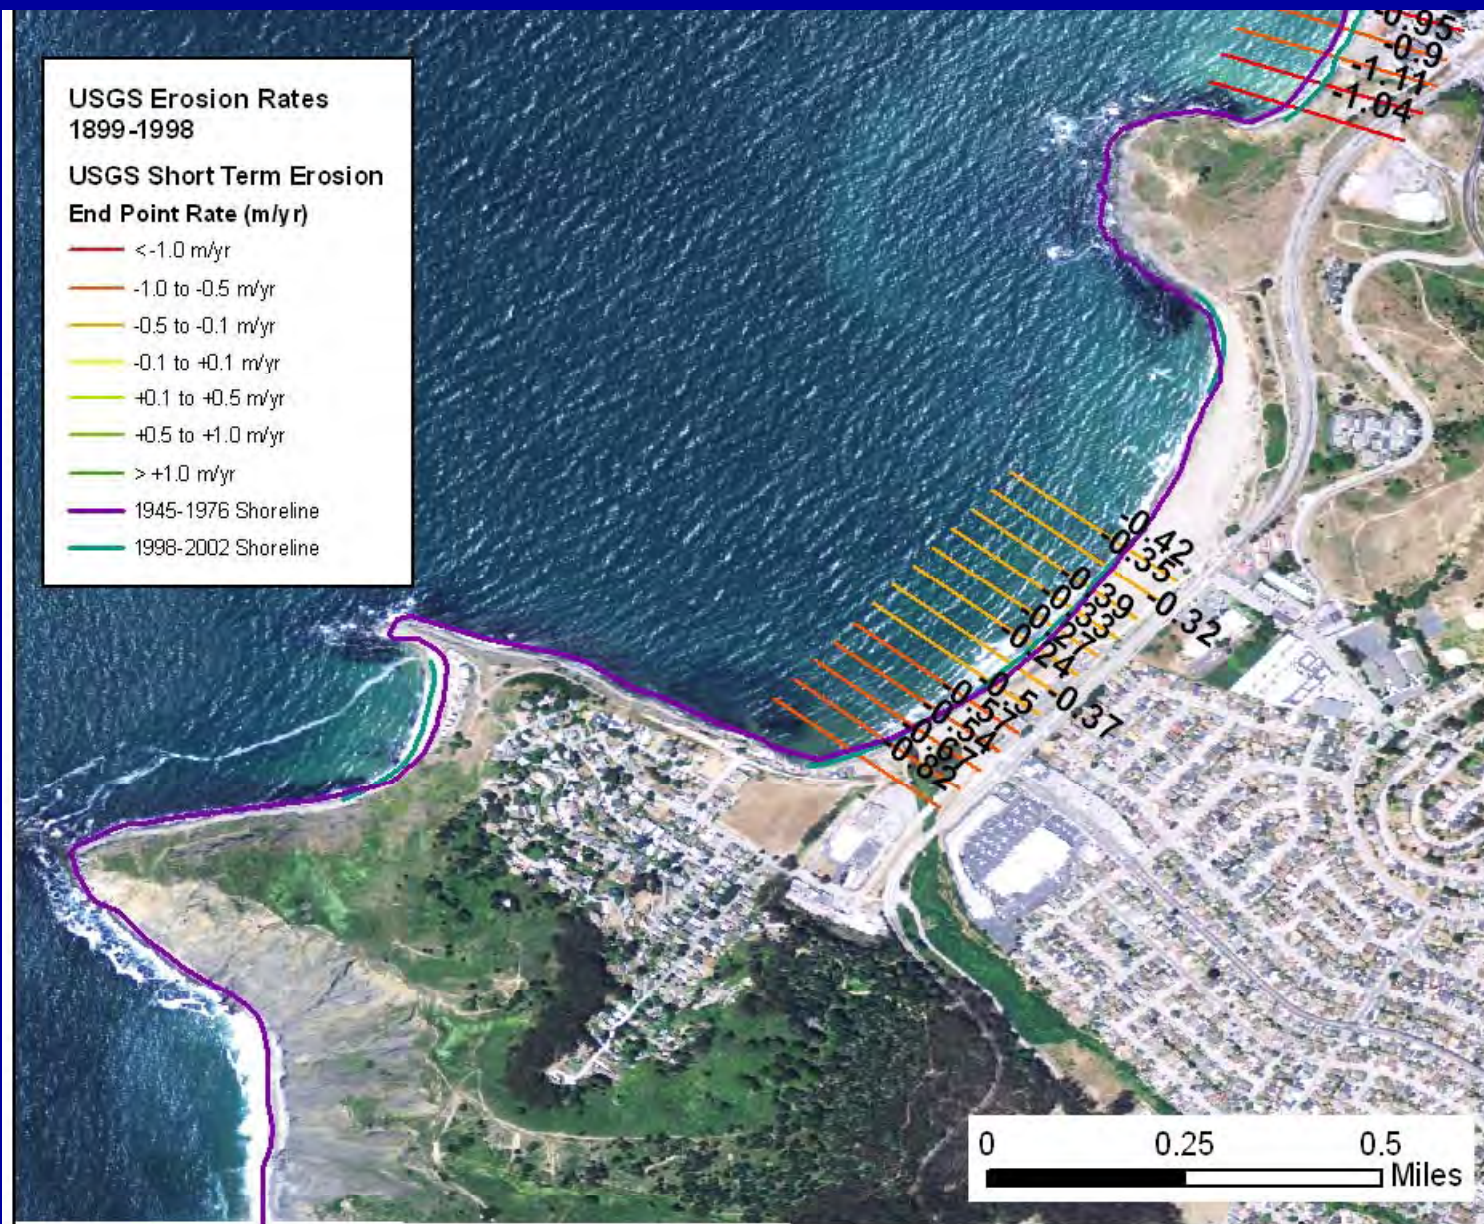
Linda Mar
Short Term
-0.2 m/yr
To
-0.8 m/yr

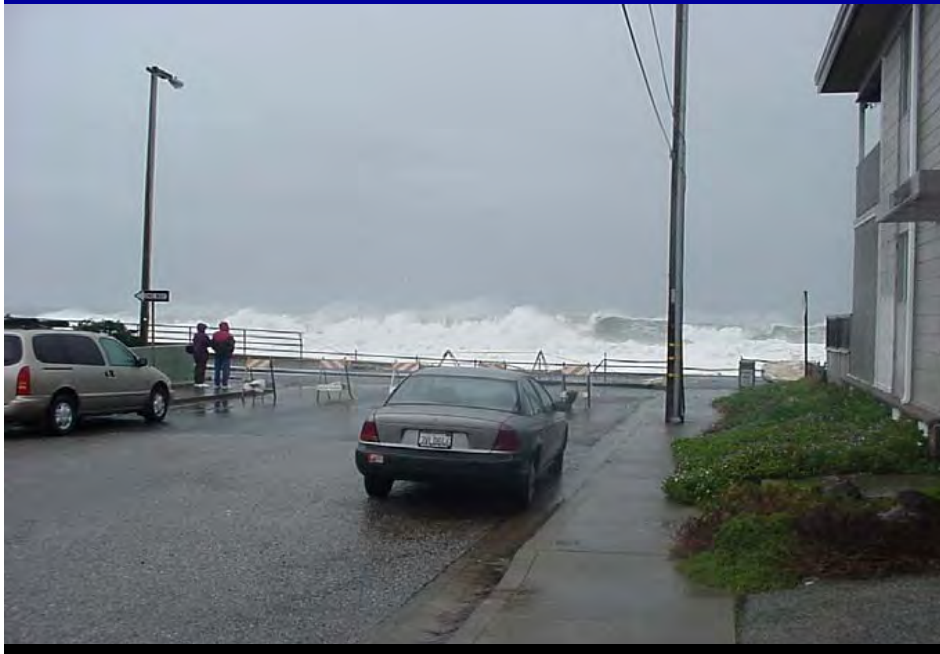
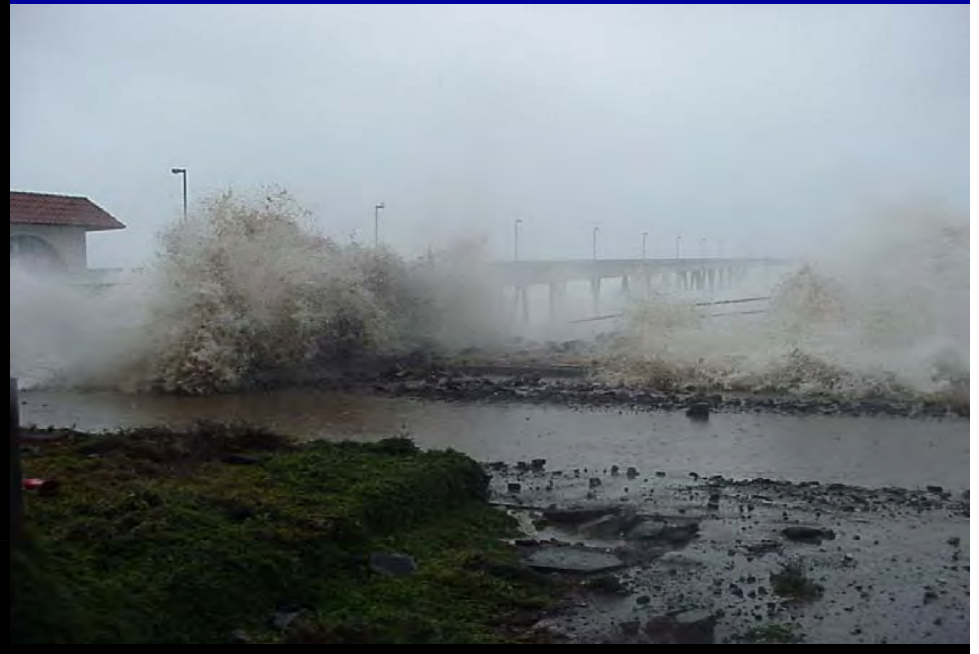
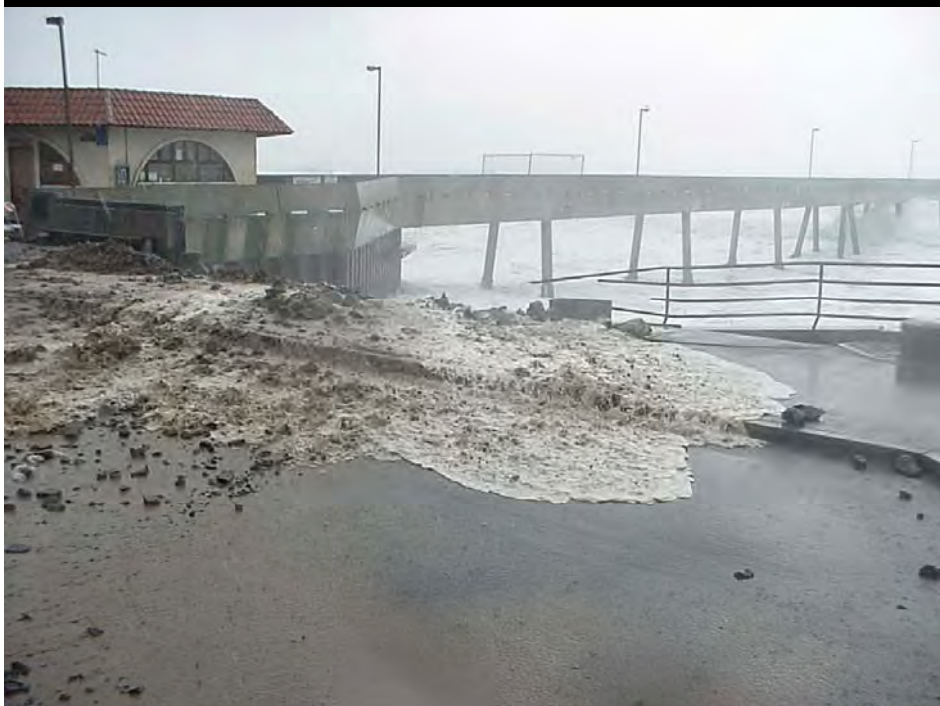
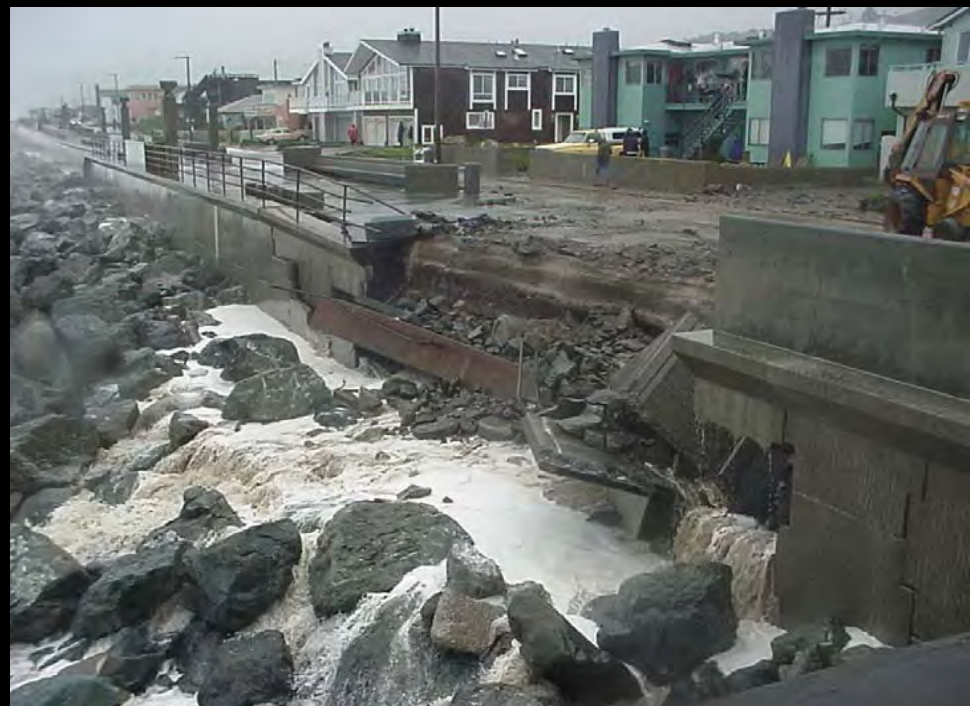
Sharp Park Seawall, Pacifica, CA – Jan 11, 2001

OVERTOPPING

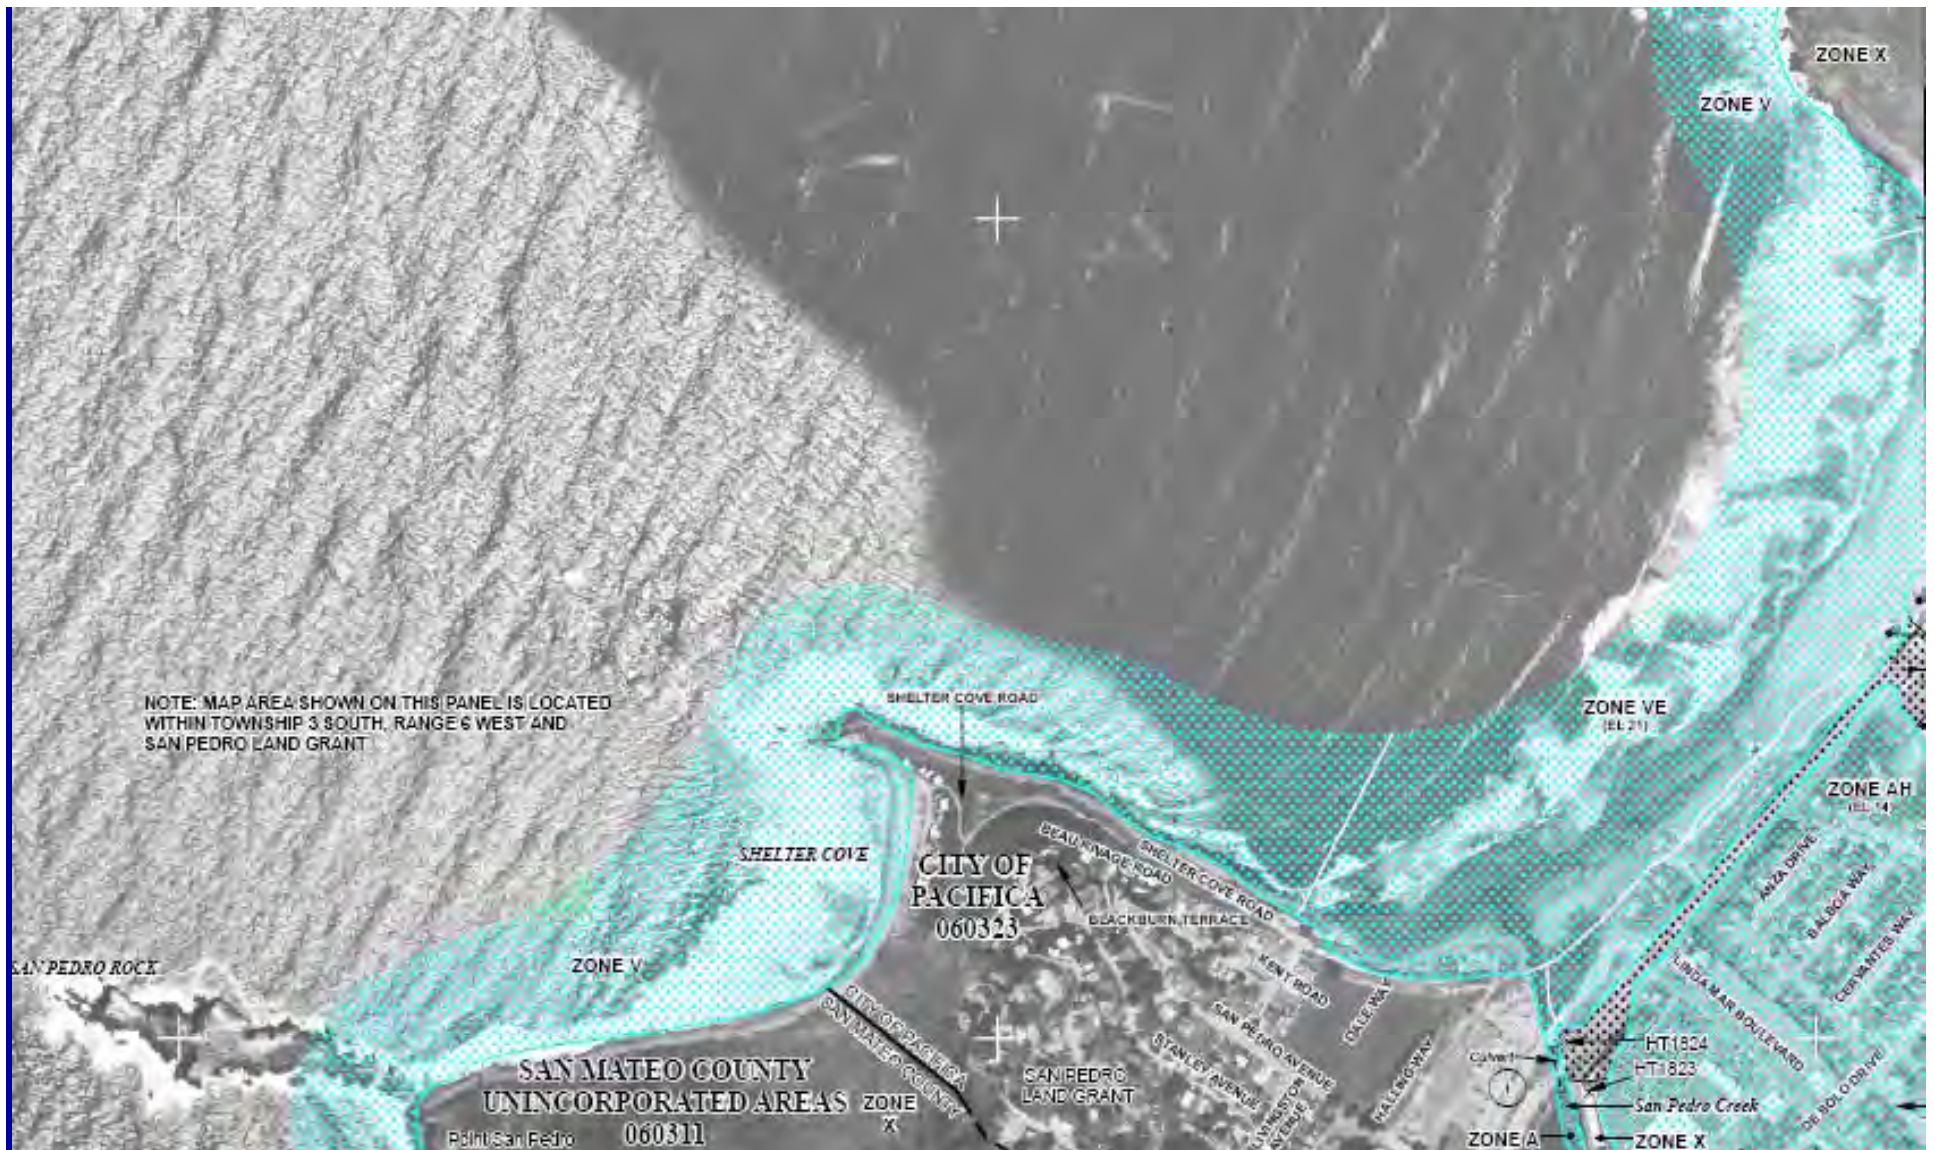
Existing Federal Emergency Management Agency (FEMA)
 Digital Flood Insurance Rate Map (DFIRM)
 Based on 1980s conditions and standard of practice
 (underestimates existing flood risk)

New FEMA Maps will show greater flood risk

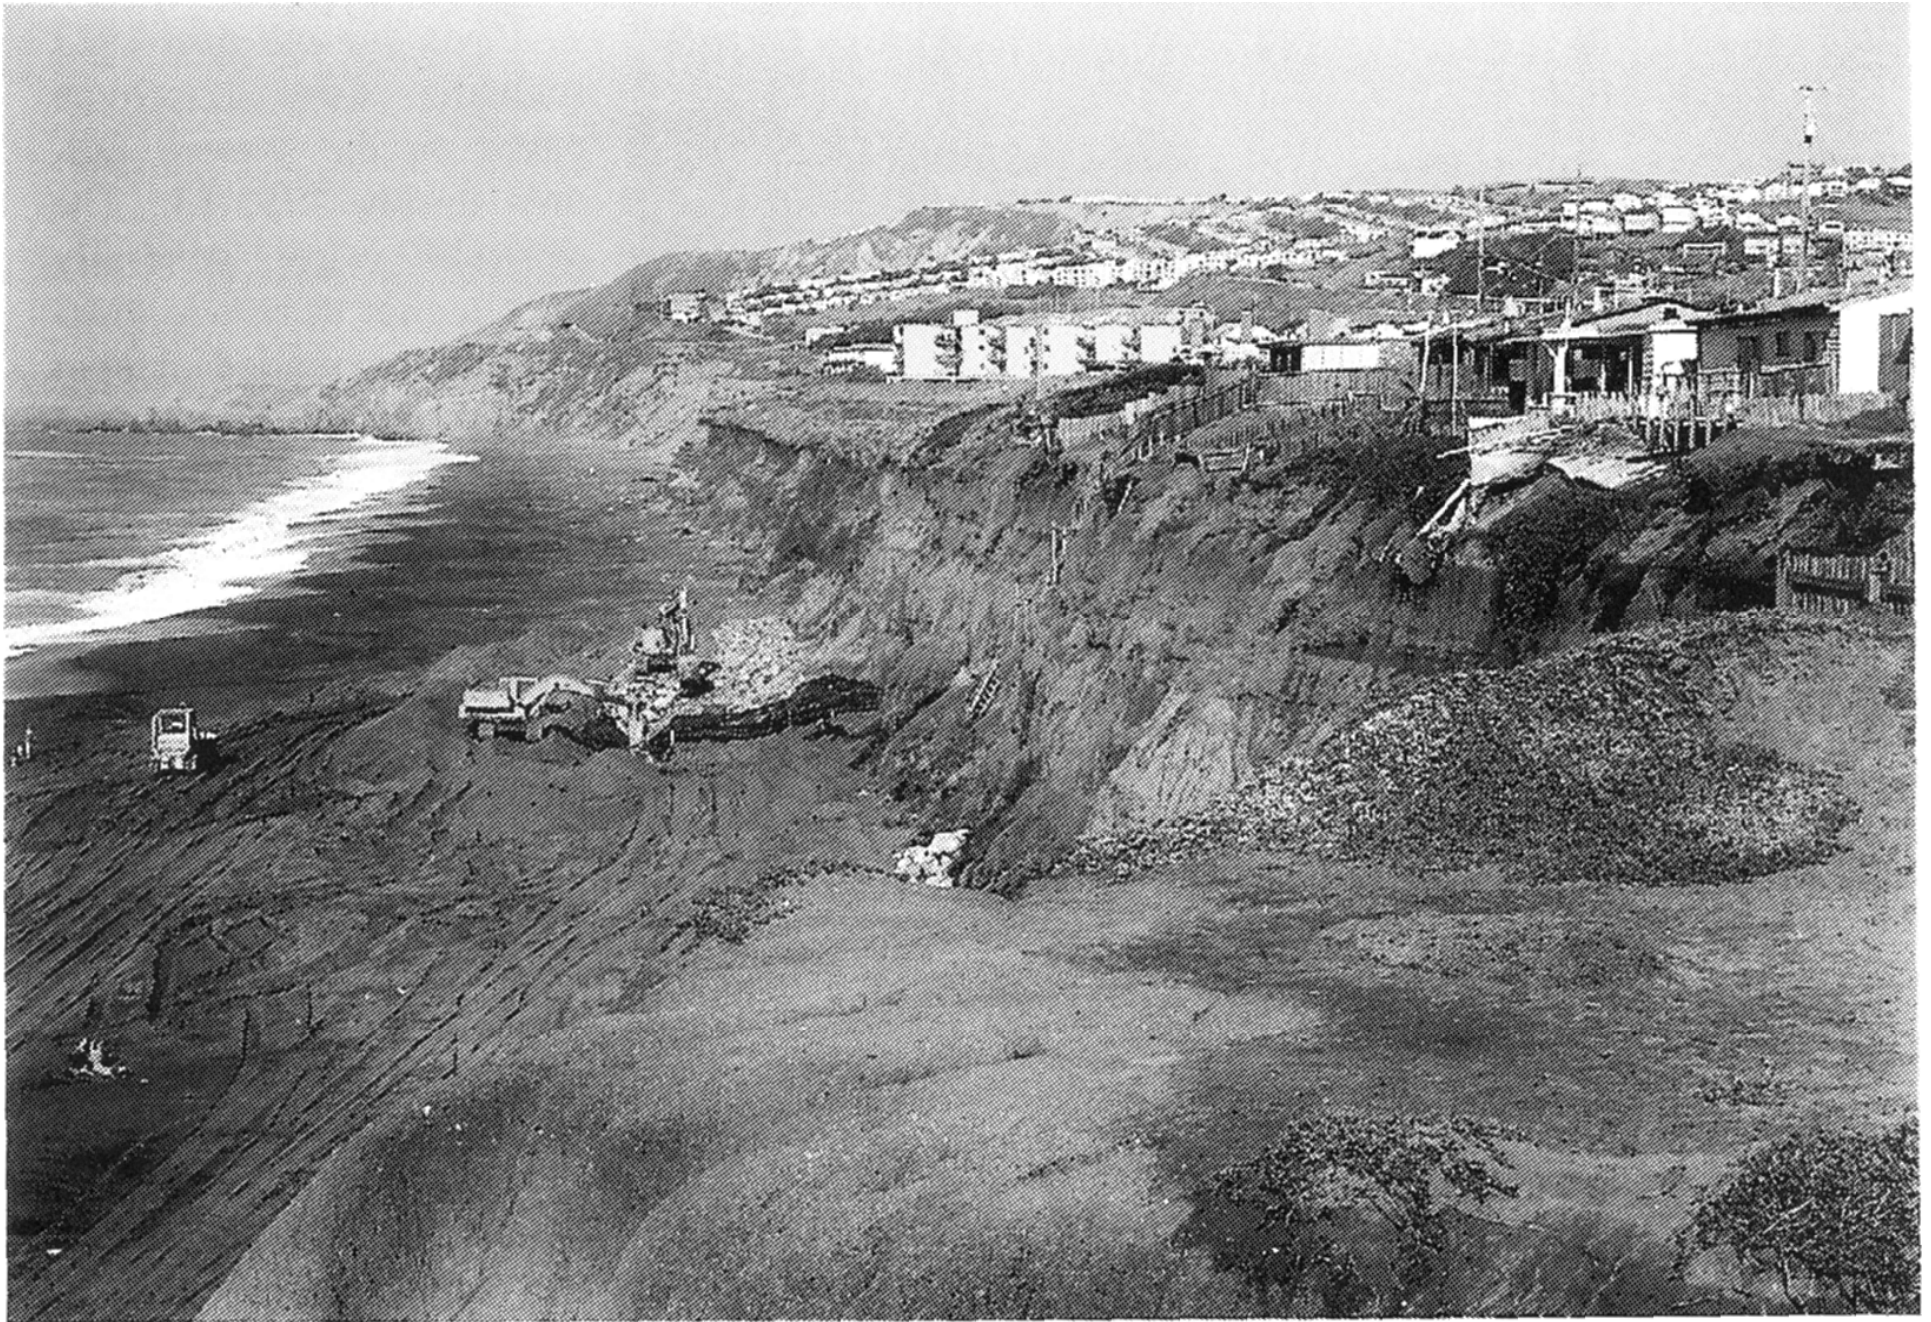
Figure 2. Pacifica bluffs in October 1983, following the last major El Niño event on the California coast, when a rock revetment was constructed.
