Coastal Hazards and Adaptation in Pacifica, CA

**Pacifica Library, Pacifica, California USA
August 16, 2010**

Bob Battalio, PE, Principal, PWA

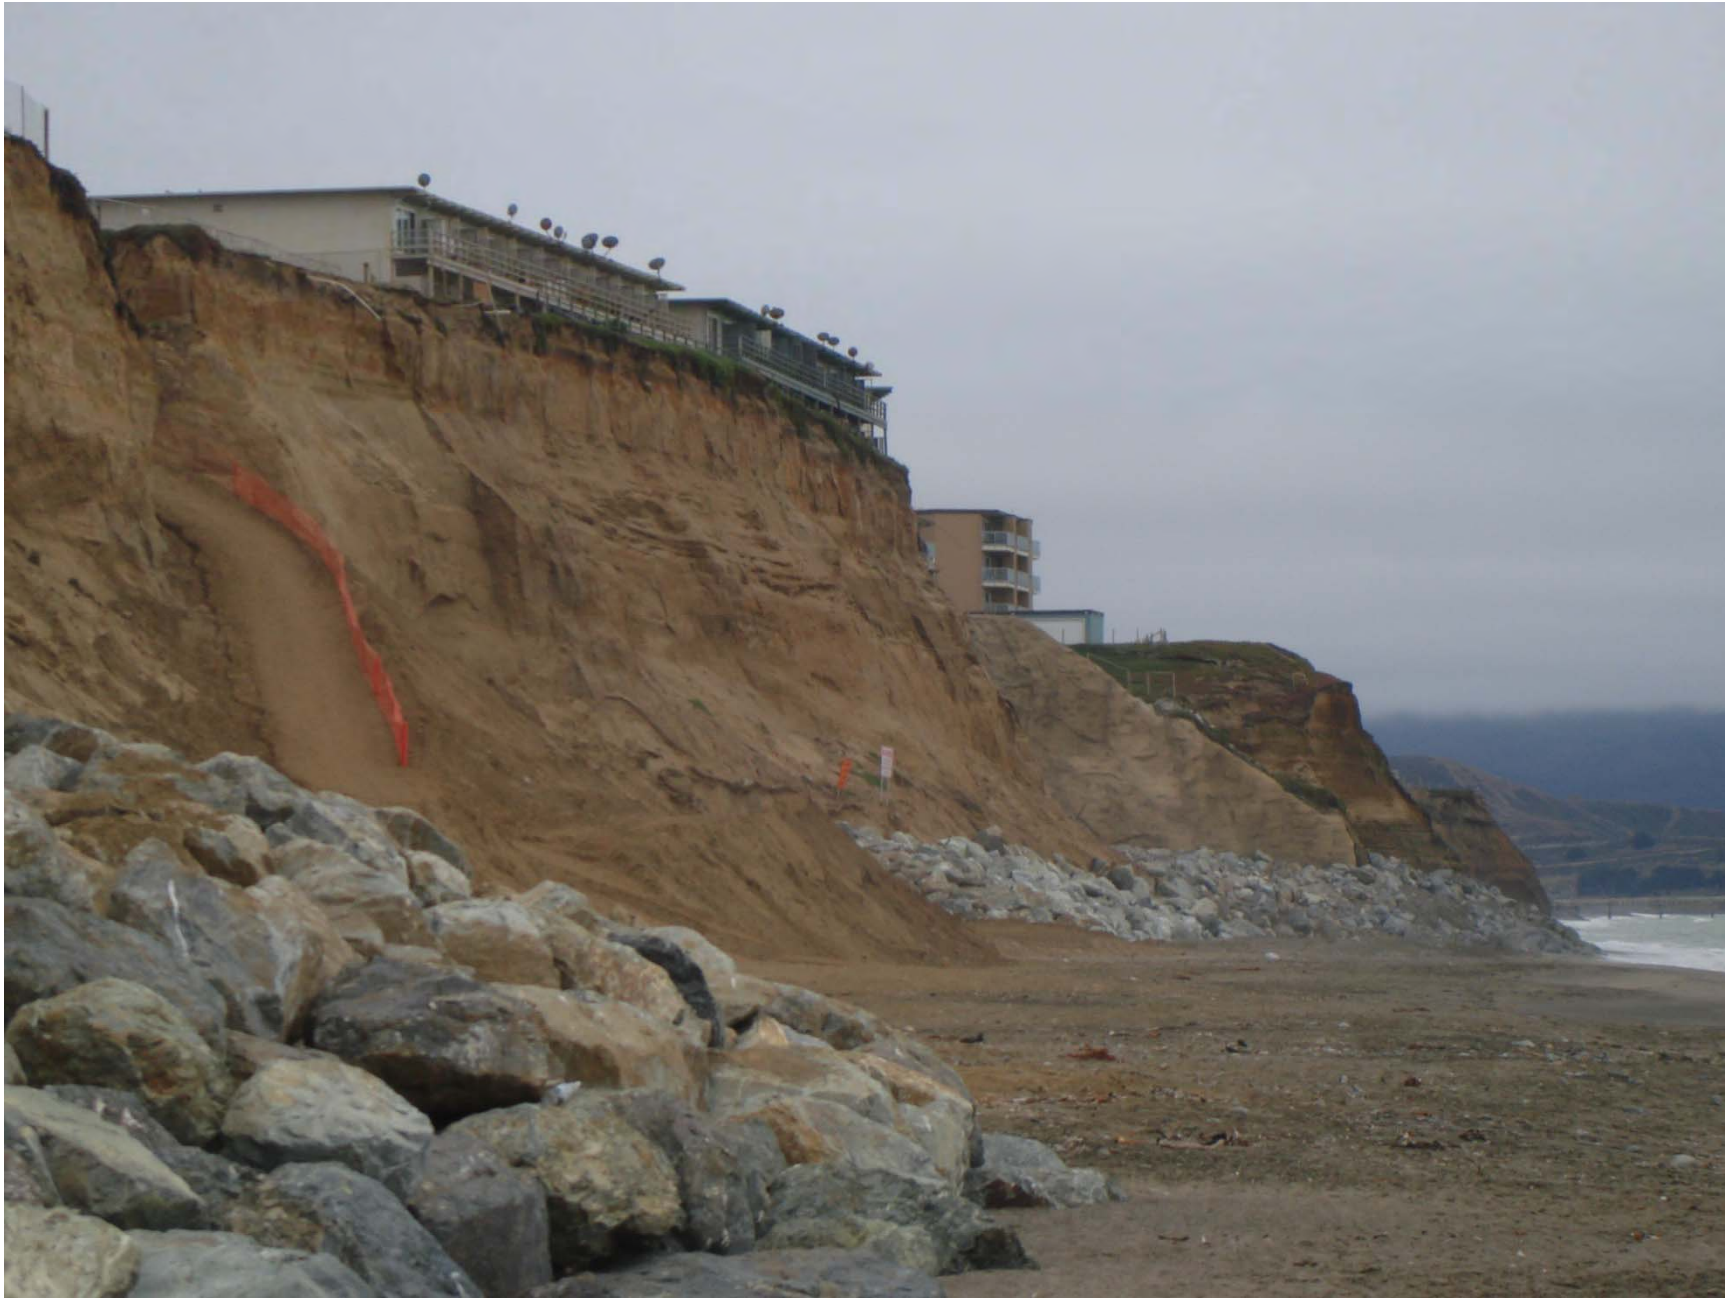
Armoring; Manor Bluffs, Pacifica Aug 2010 © Bob Battalio, 2010

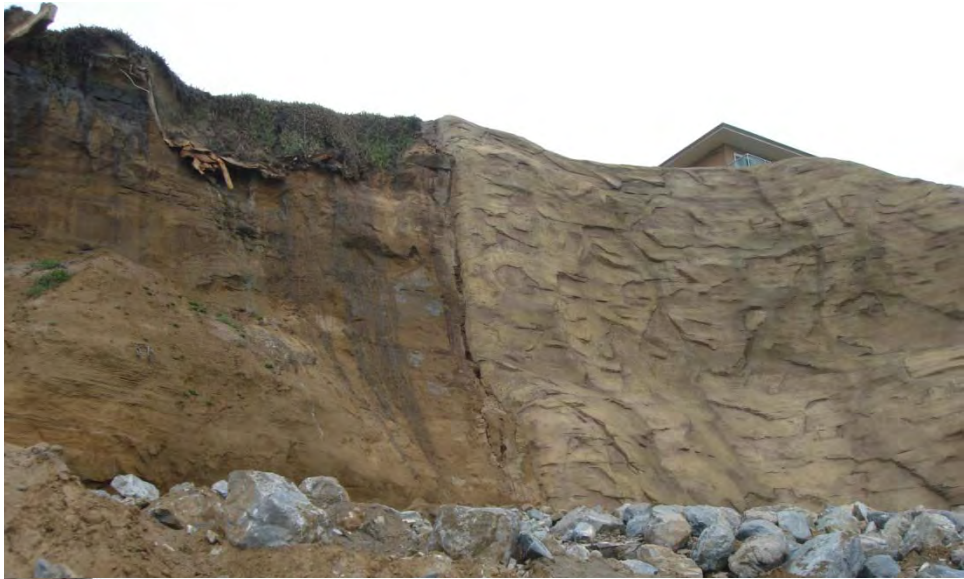
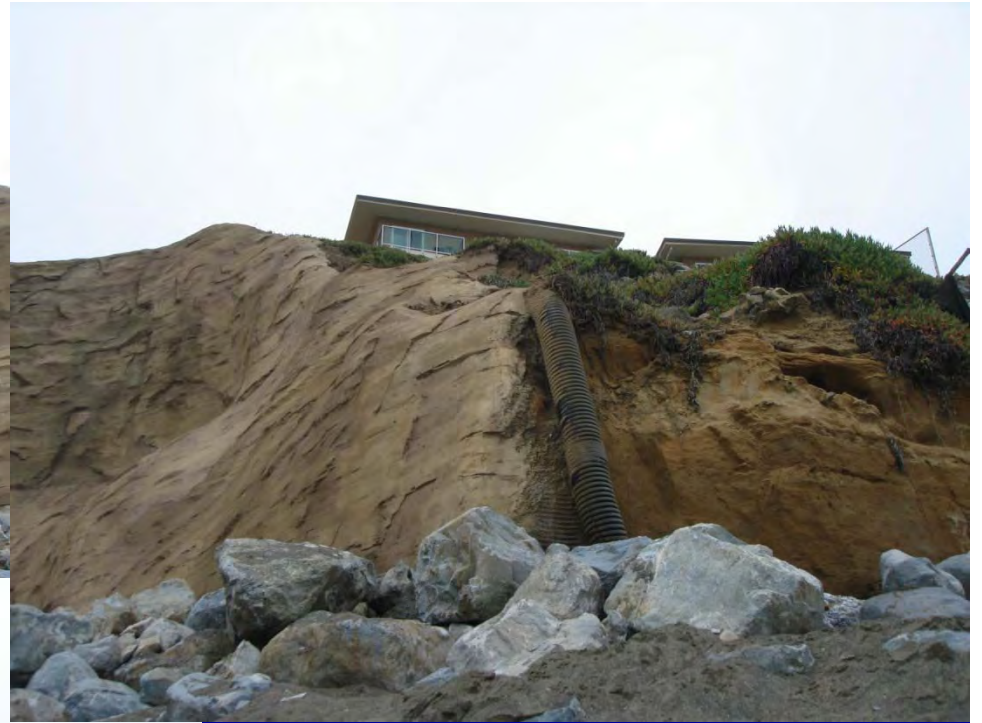
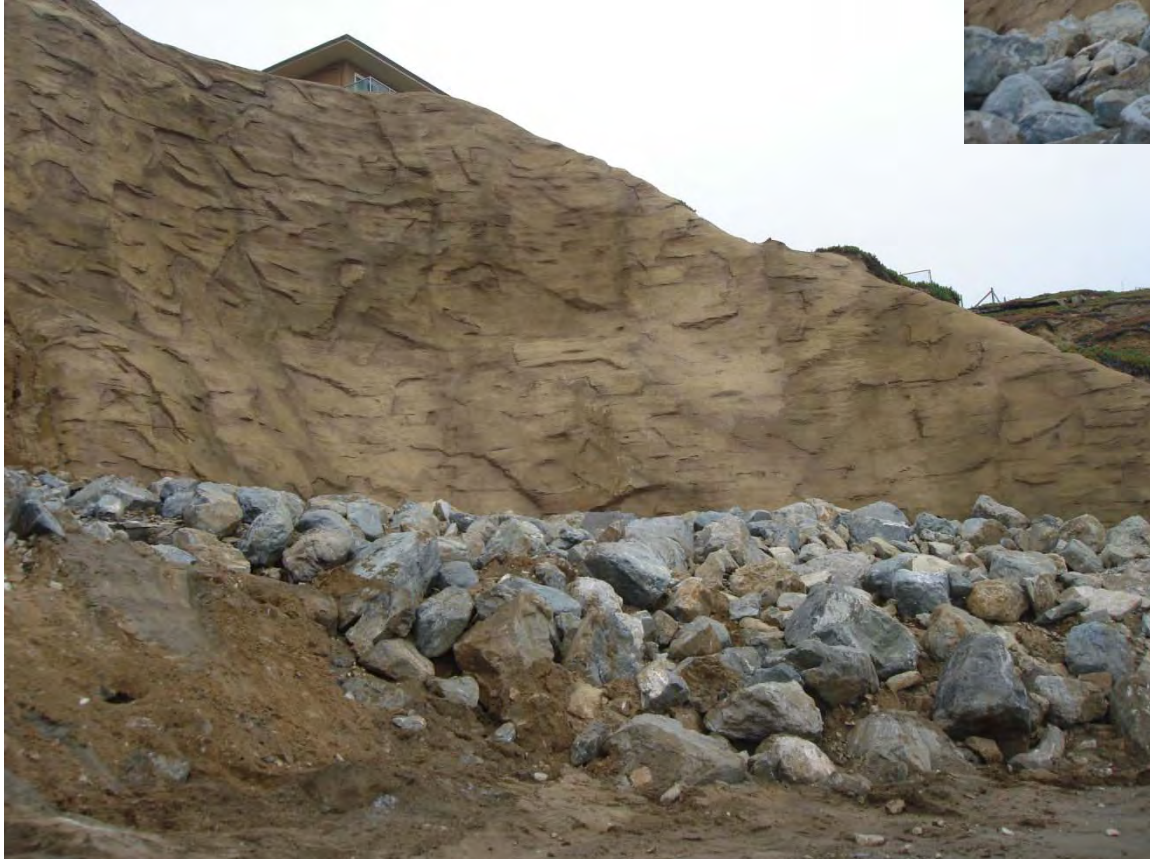
“Shotcrete” Reinforced concrete retaining wall, with color and texture

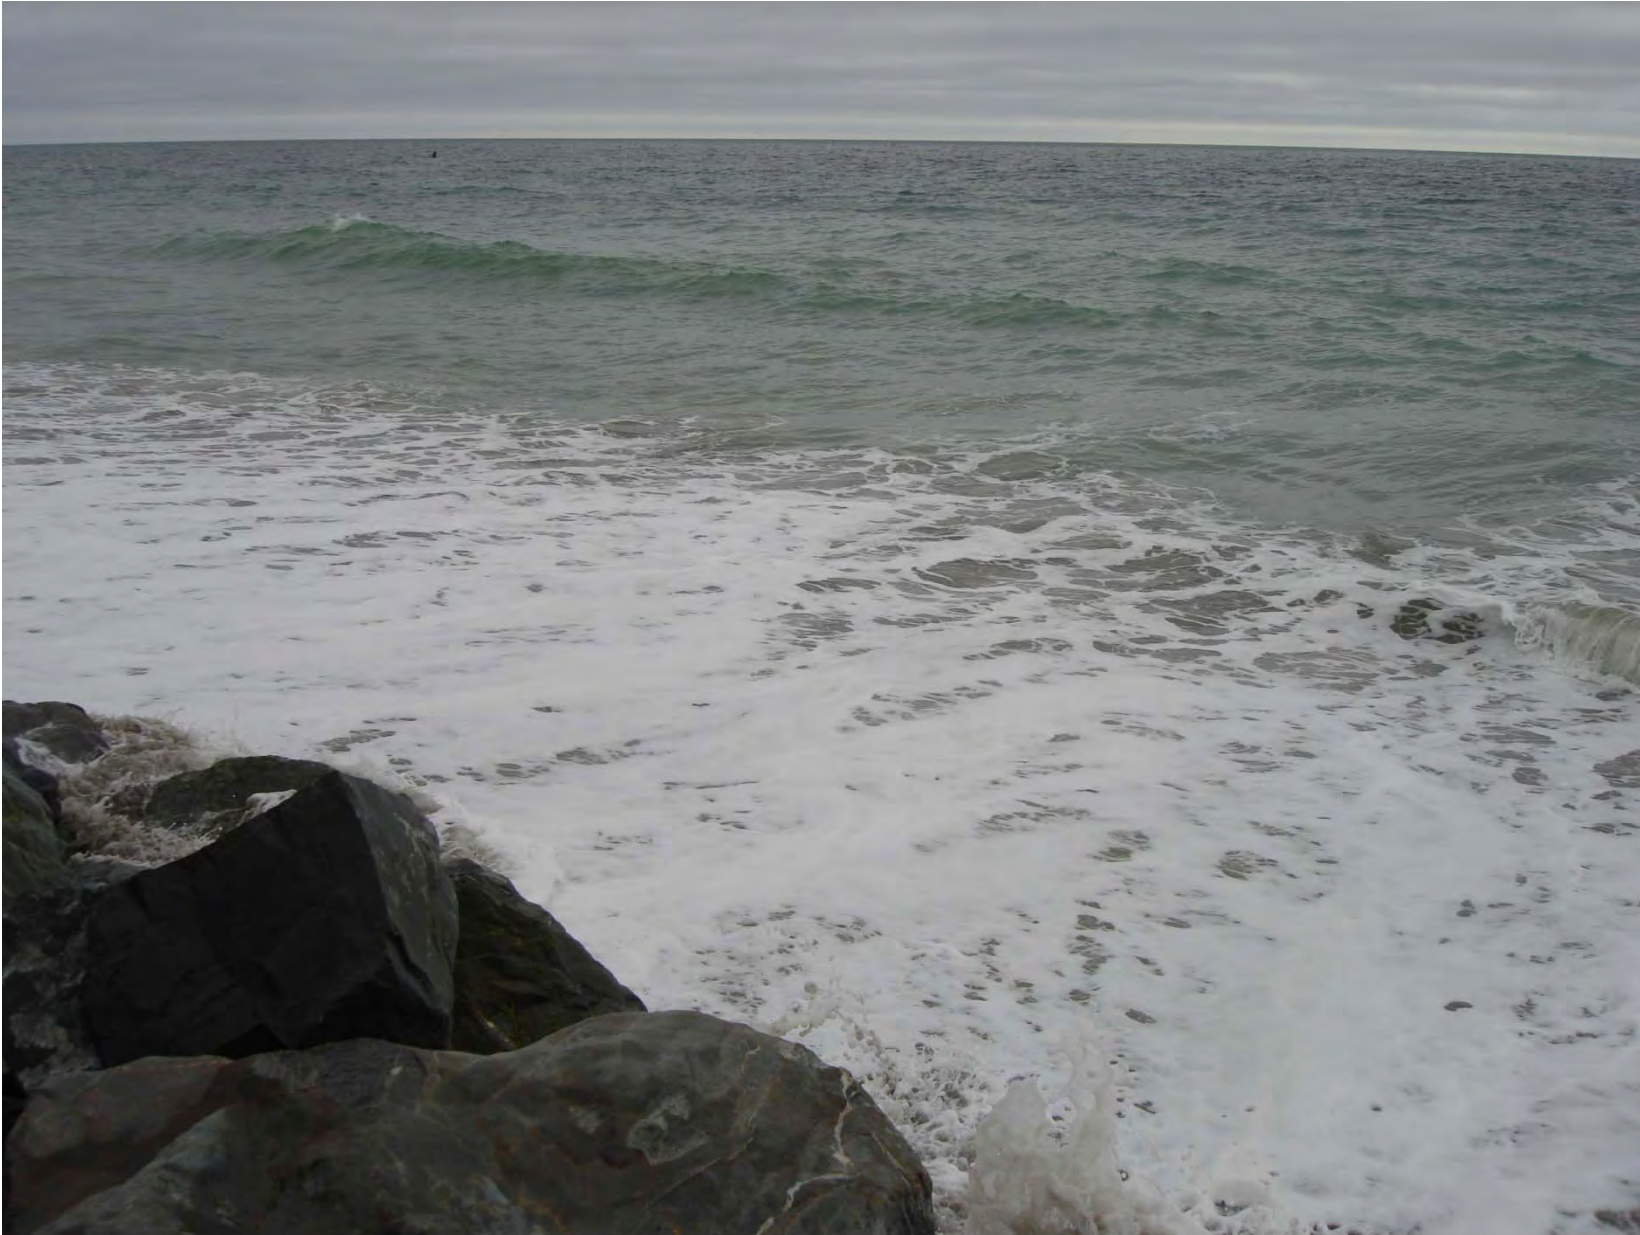
No dry beach below “The Bluffs at Pacifica,” Pacifica Aug 2010 © Bob Battalio, 2010

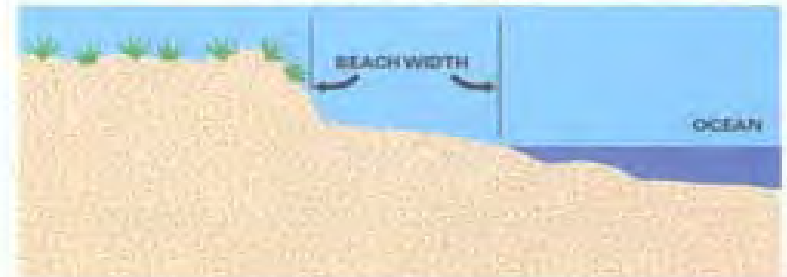
A. Initial shoreline showing beach width

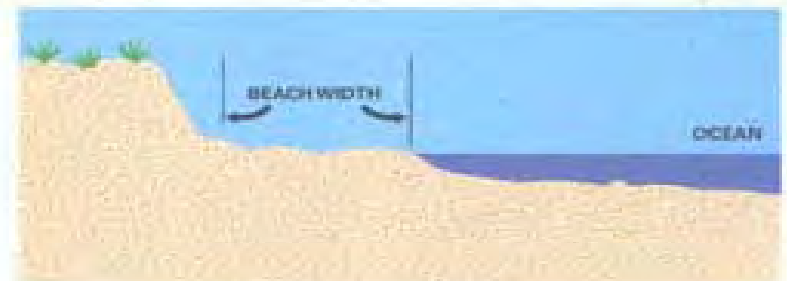
B. Shoreline after sea level rise & associated dune or bluff erosion, although the shoreline has moved landward, the beach width remains the same

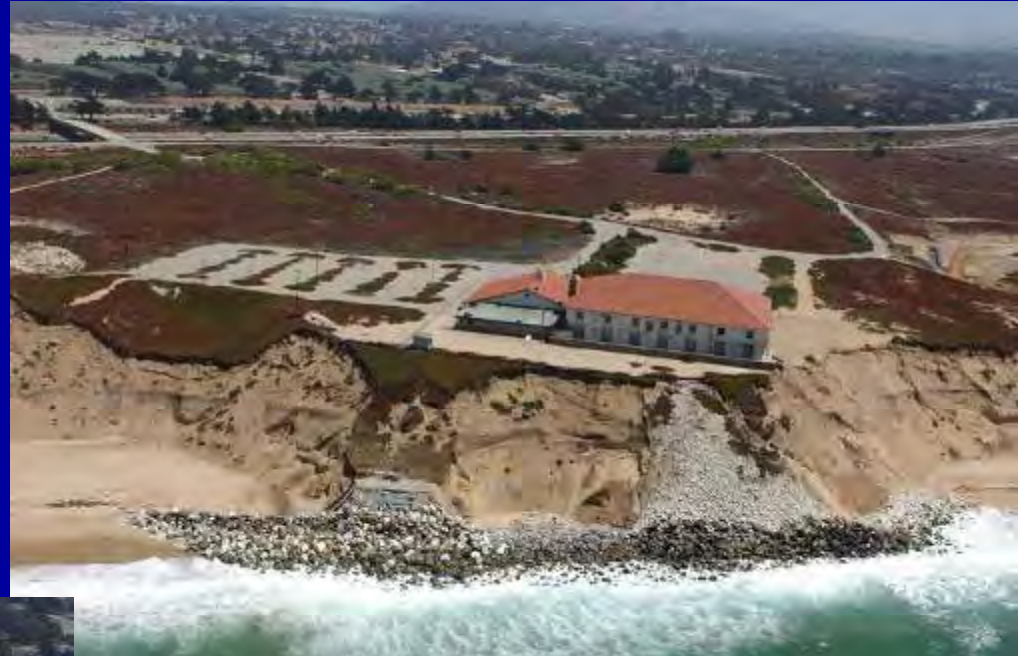
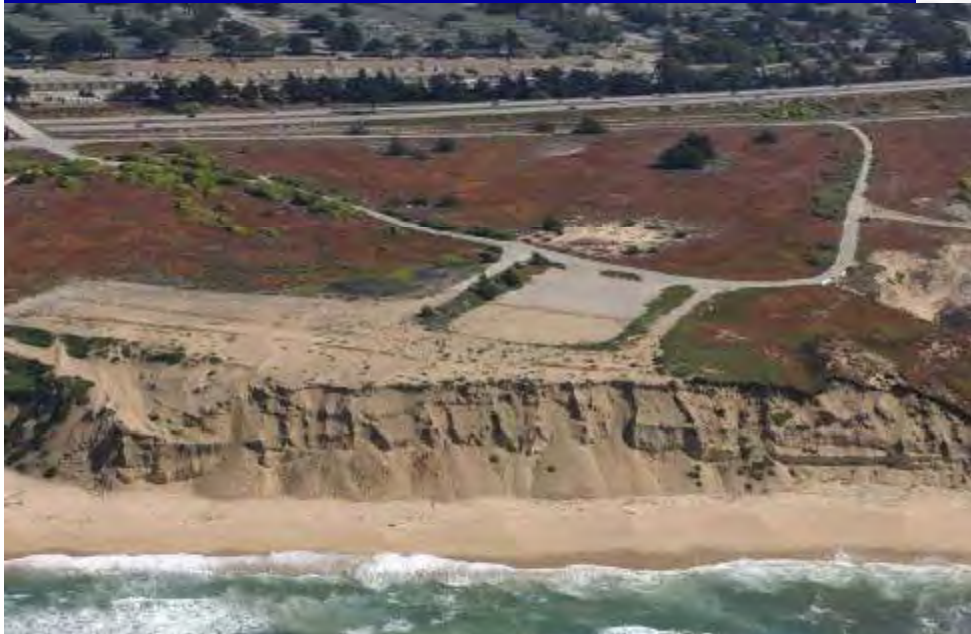
Example: Officer's Club, Fort Ord, Monterey Bay, CA showing beach recovery after armoring removed and back beach erosion.

2002

2005

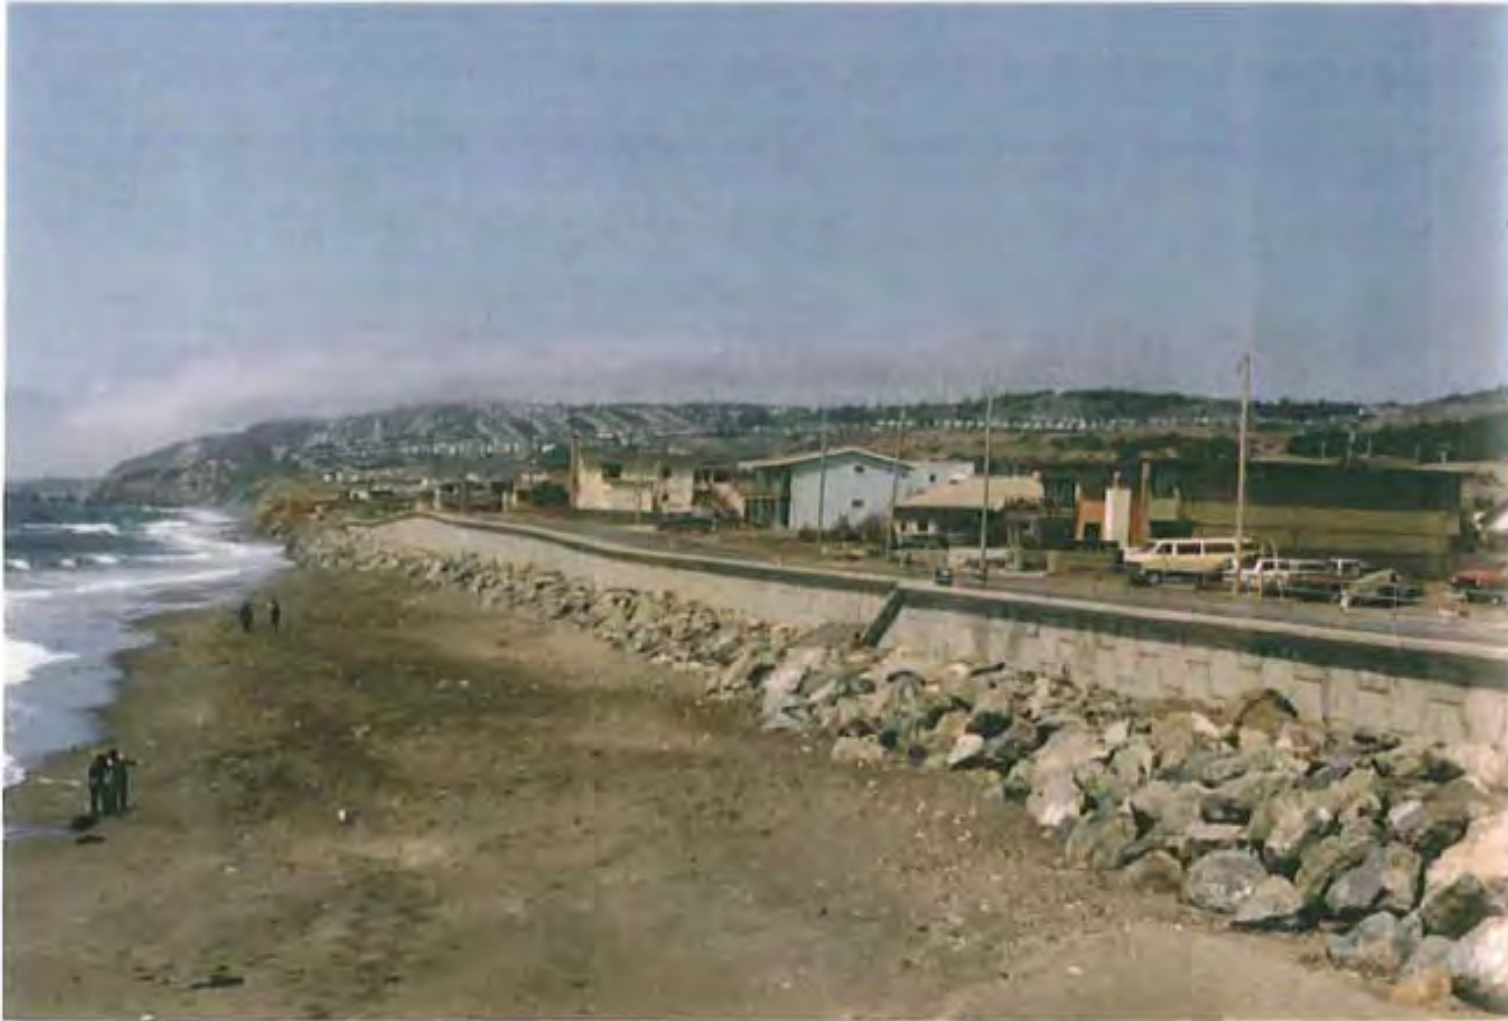
Beach Blvd Seawall soon after construction

Photograph 6. Recently constructed reinforced earth seawall with armor stone toe protection. This wall extends along Beach Boulevard north of the Fishing Pier in Pacifica (August 1985).

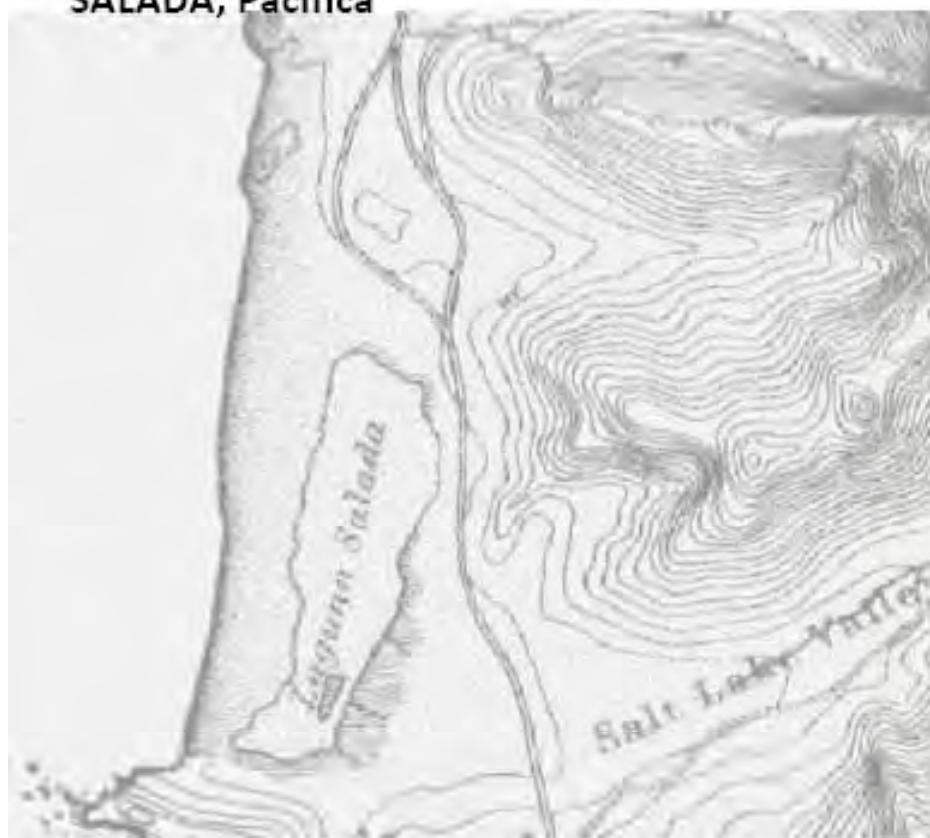
- Large wide, low gradient valley (floodplain) at east end of lagoon wetlands; riparian scrub position
- lagoon mostly open water; narrow fringing marsh

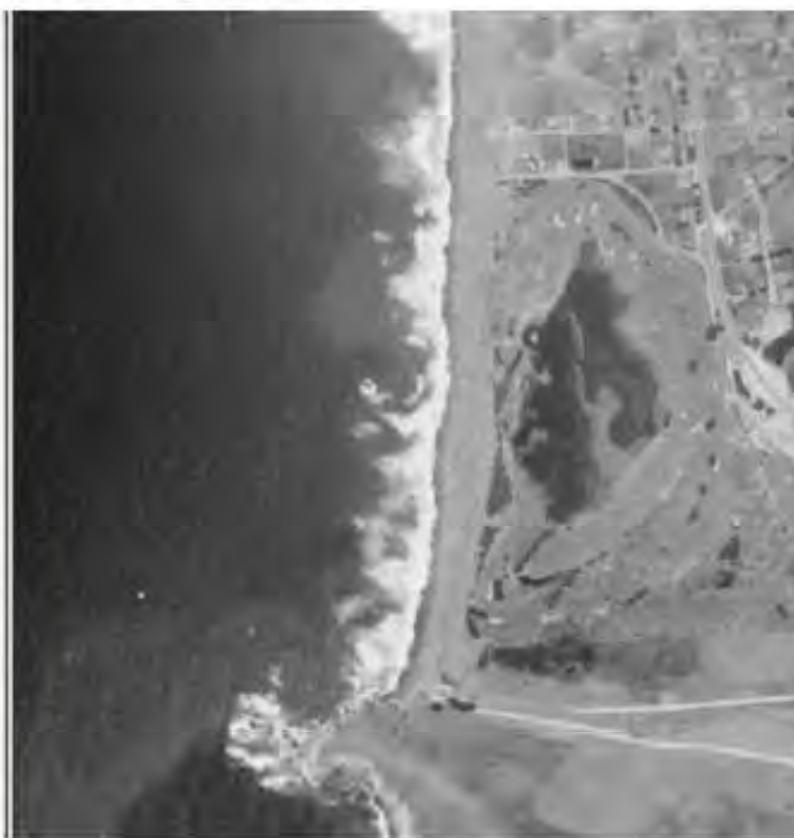
1946 aerial photo

- Golf course fills valley and south lagoon, & landward edge of washover terrace
- lagoon remnant mostly emergent marsh; little open water (drained)

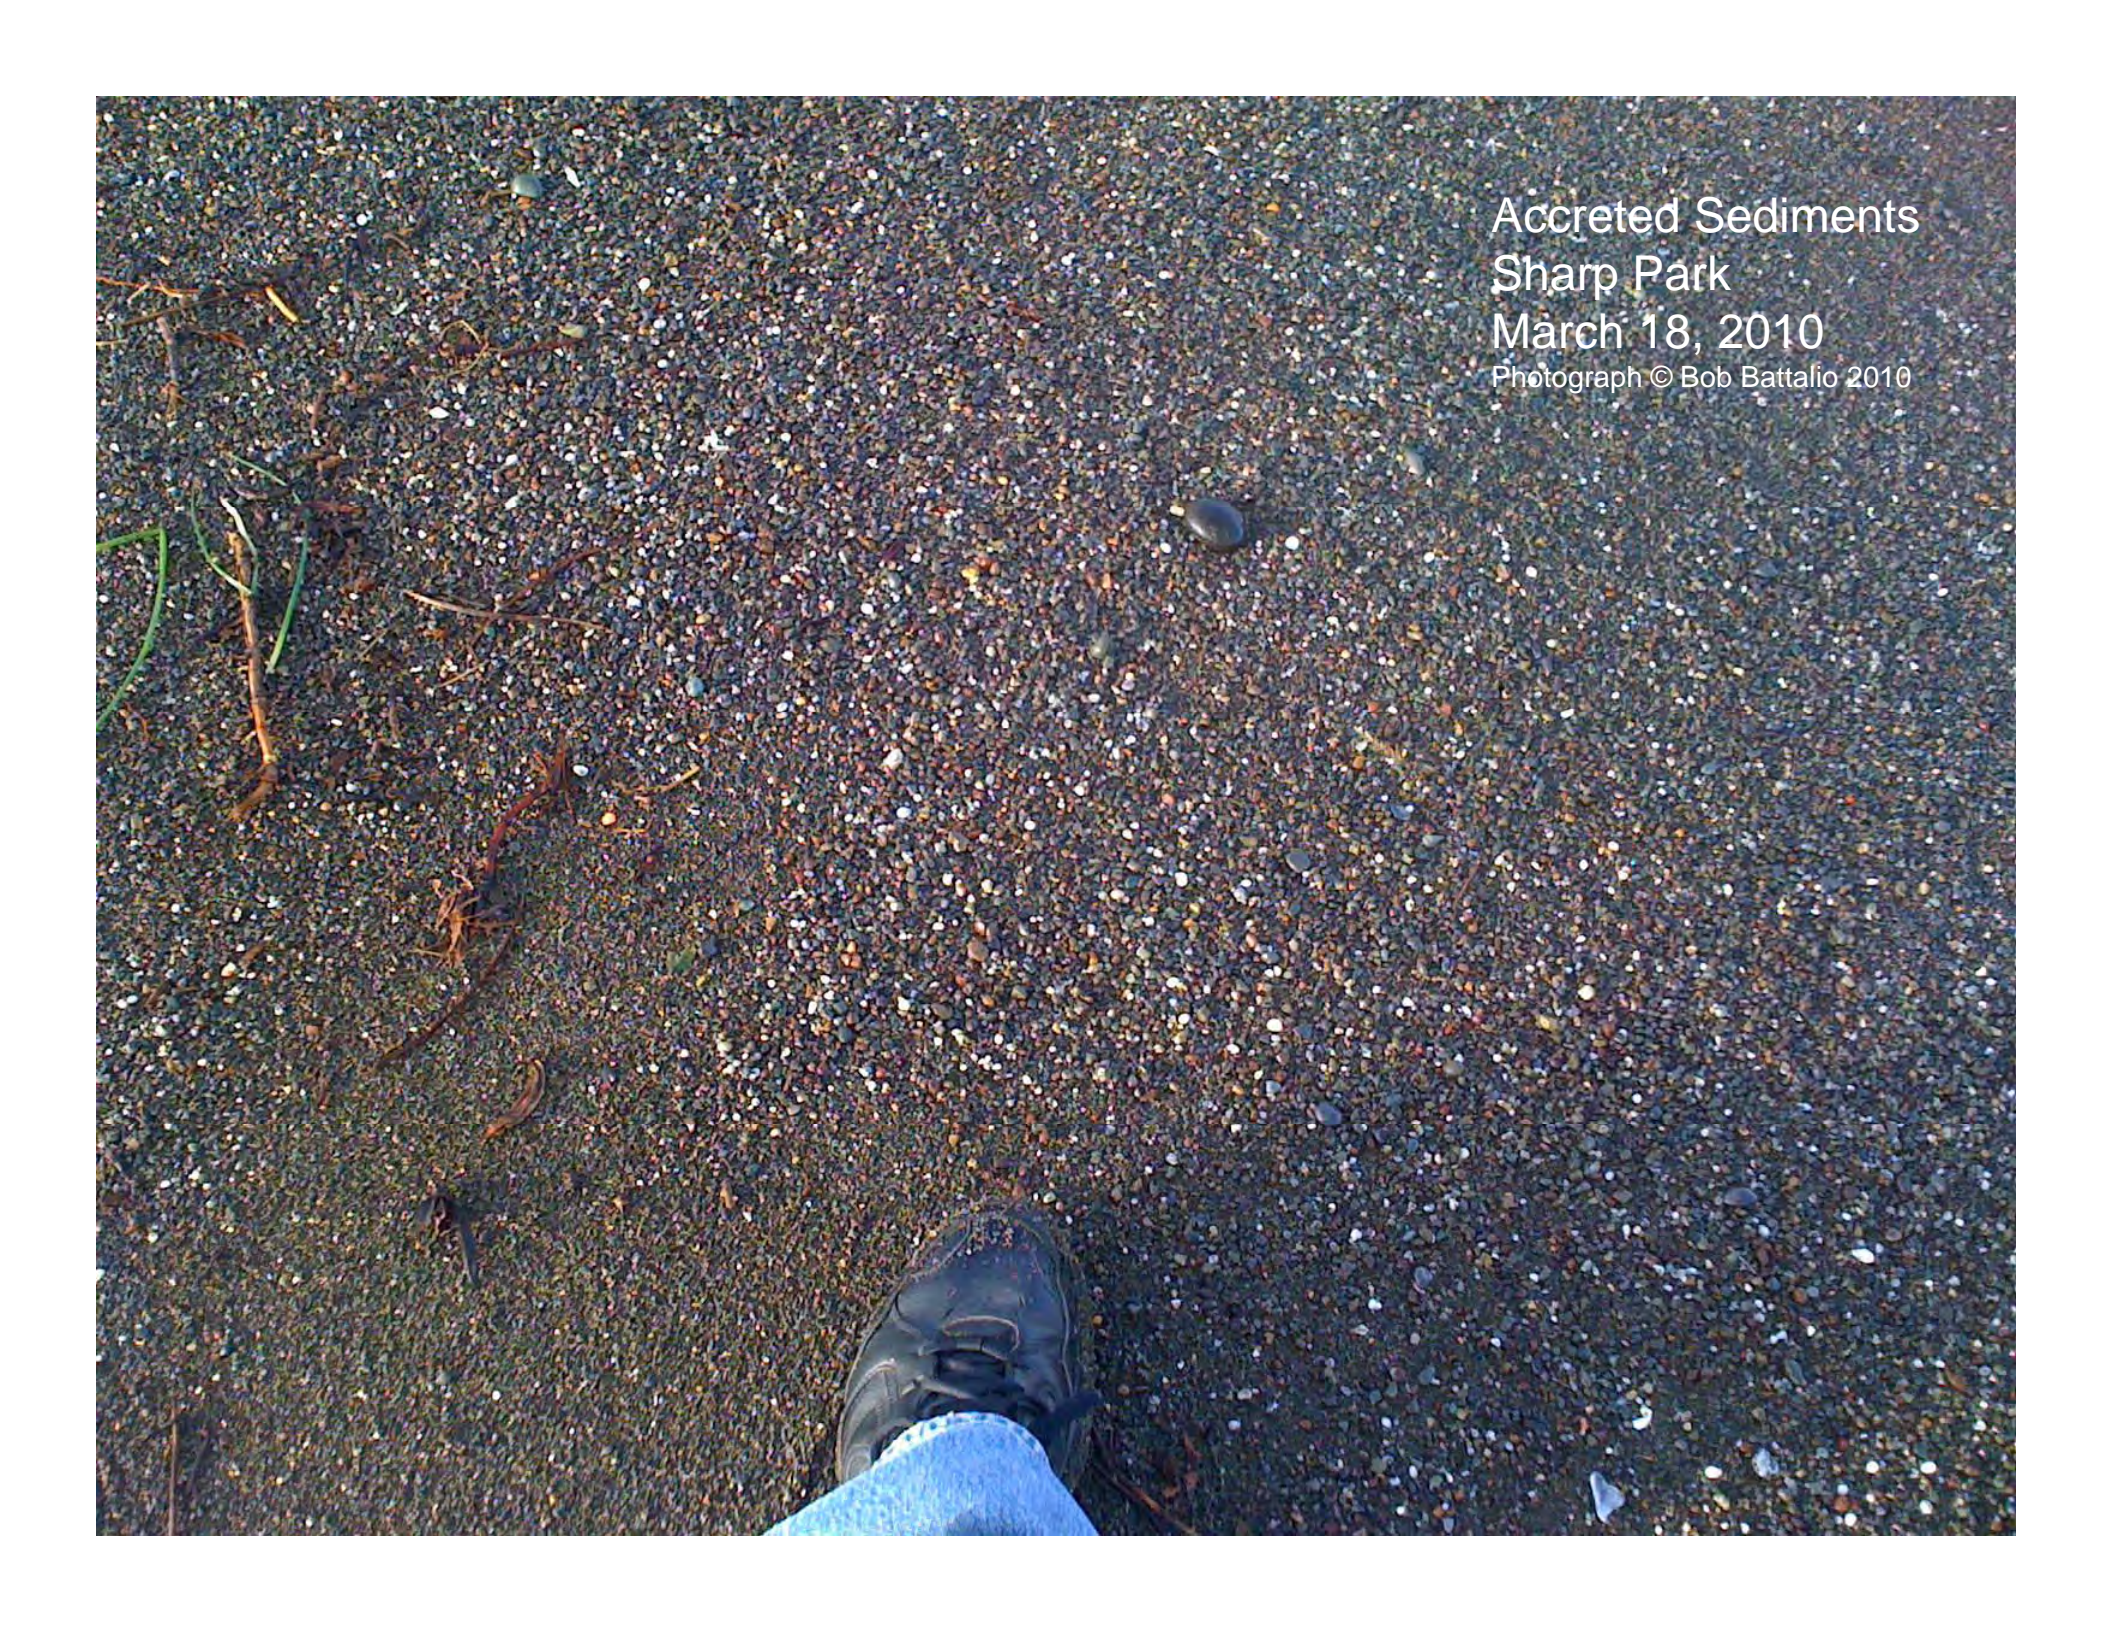
Accreted Sediments
Sharp Park
March 18, 2010
Photograph © Bob Battalio 2010

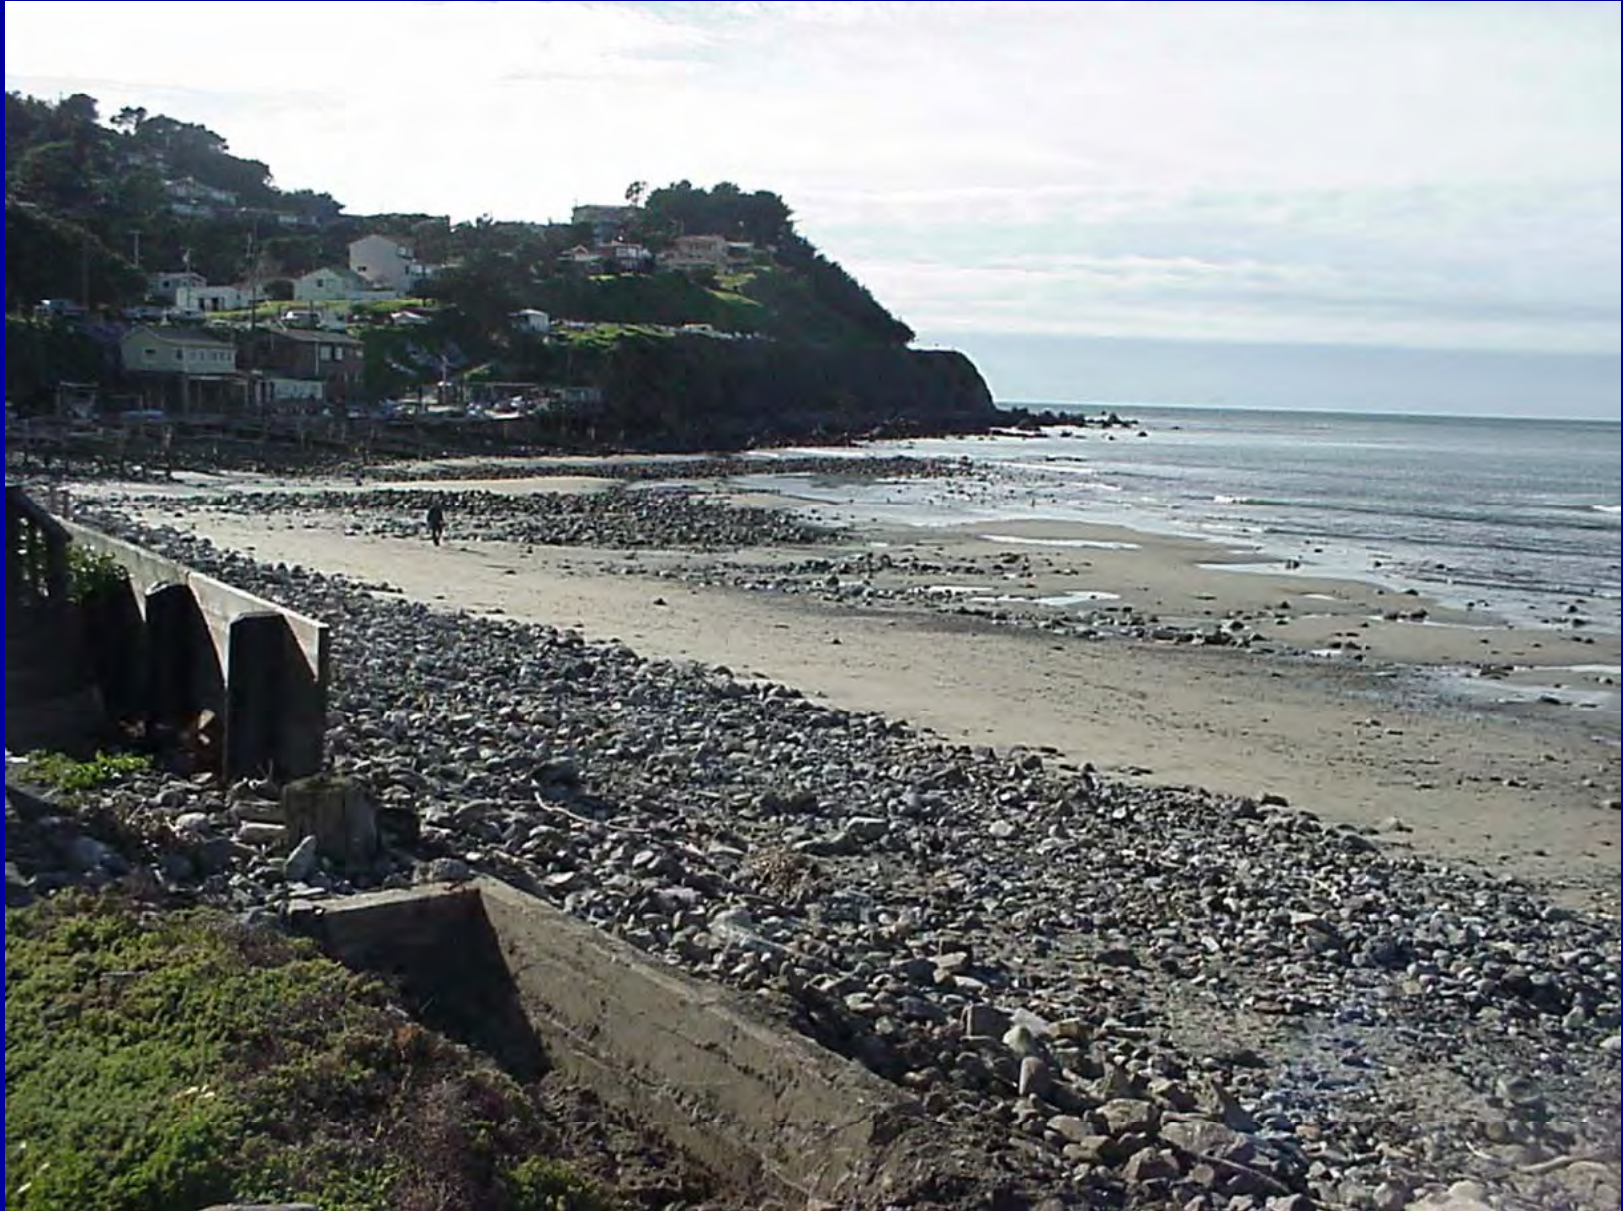
Linda Mar – Pt San Pedro - cobble substrate with sand cover

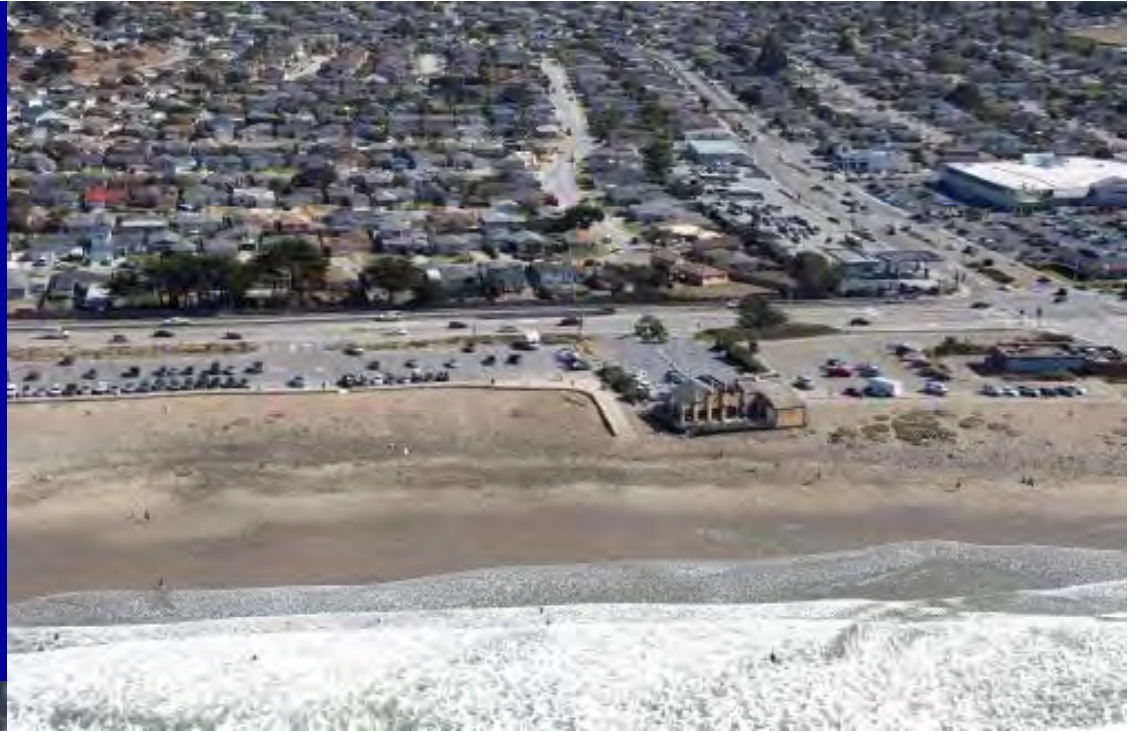
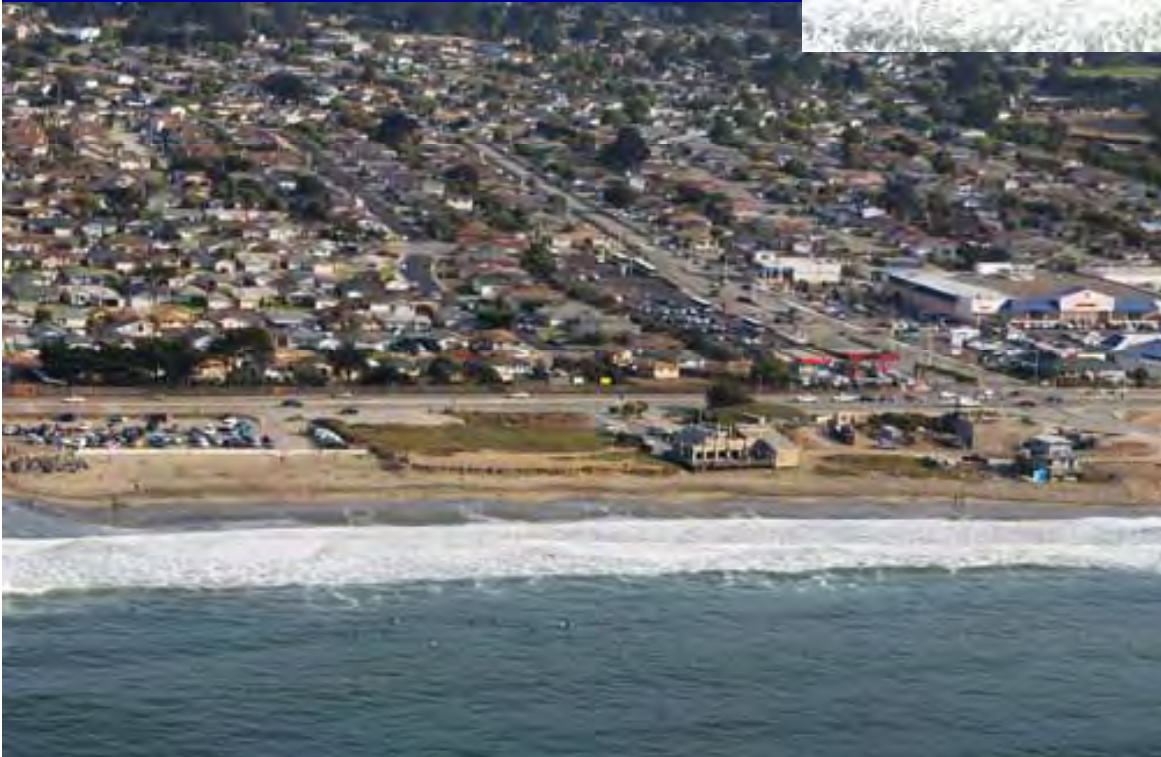
Pacifica State Beach
Managed
Retreat Project

Allow shore to migrate landward by progressively realigning infrastructure and functions; Maintains ecology, recreation, natural aesthetics at cost of demolition and reconstruction of development over time (e.g. Linda Mar Beach, Laguna Salada)

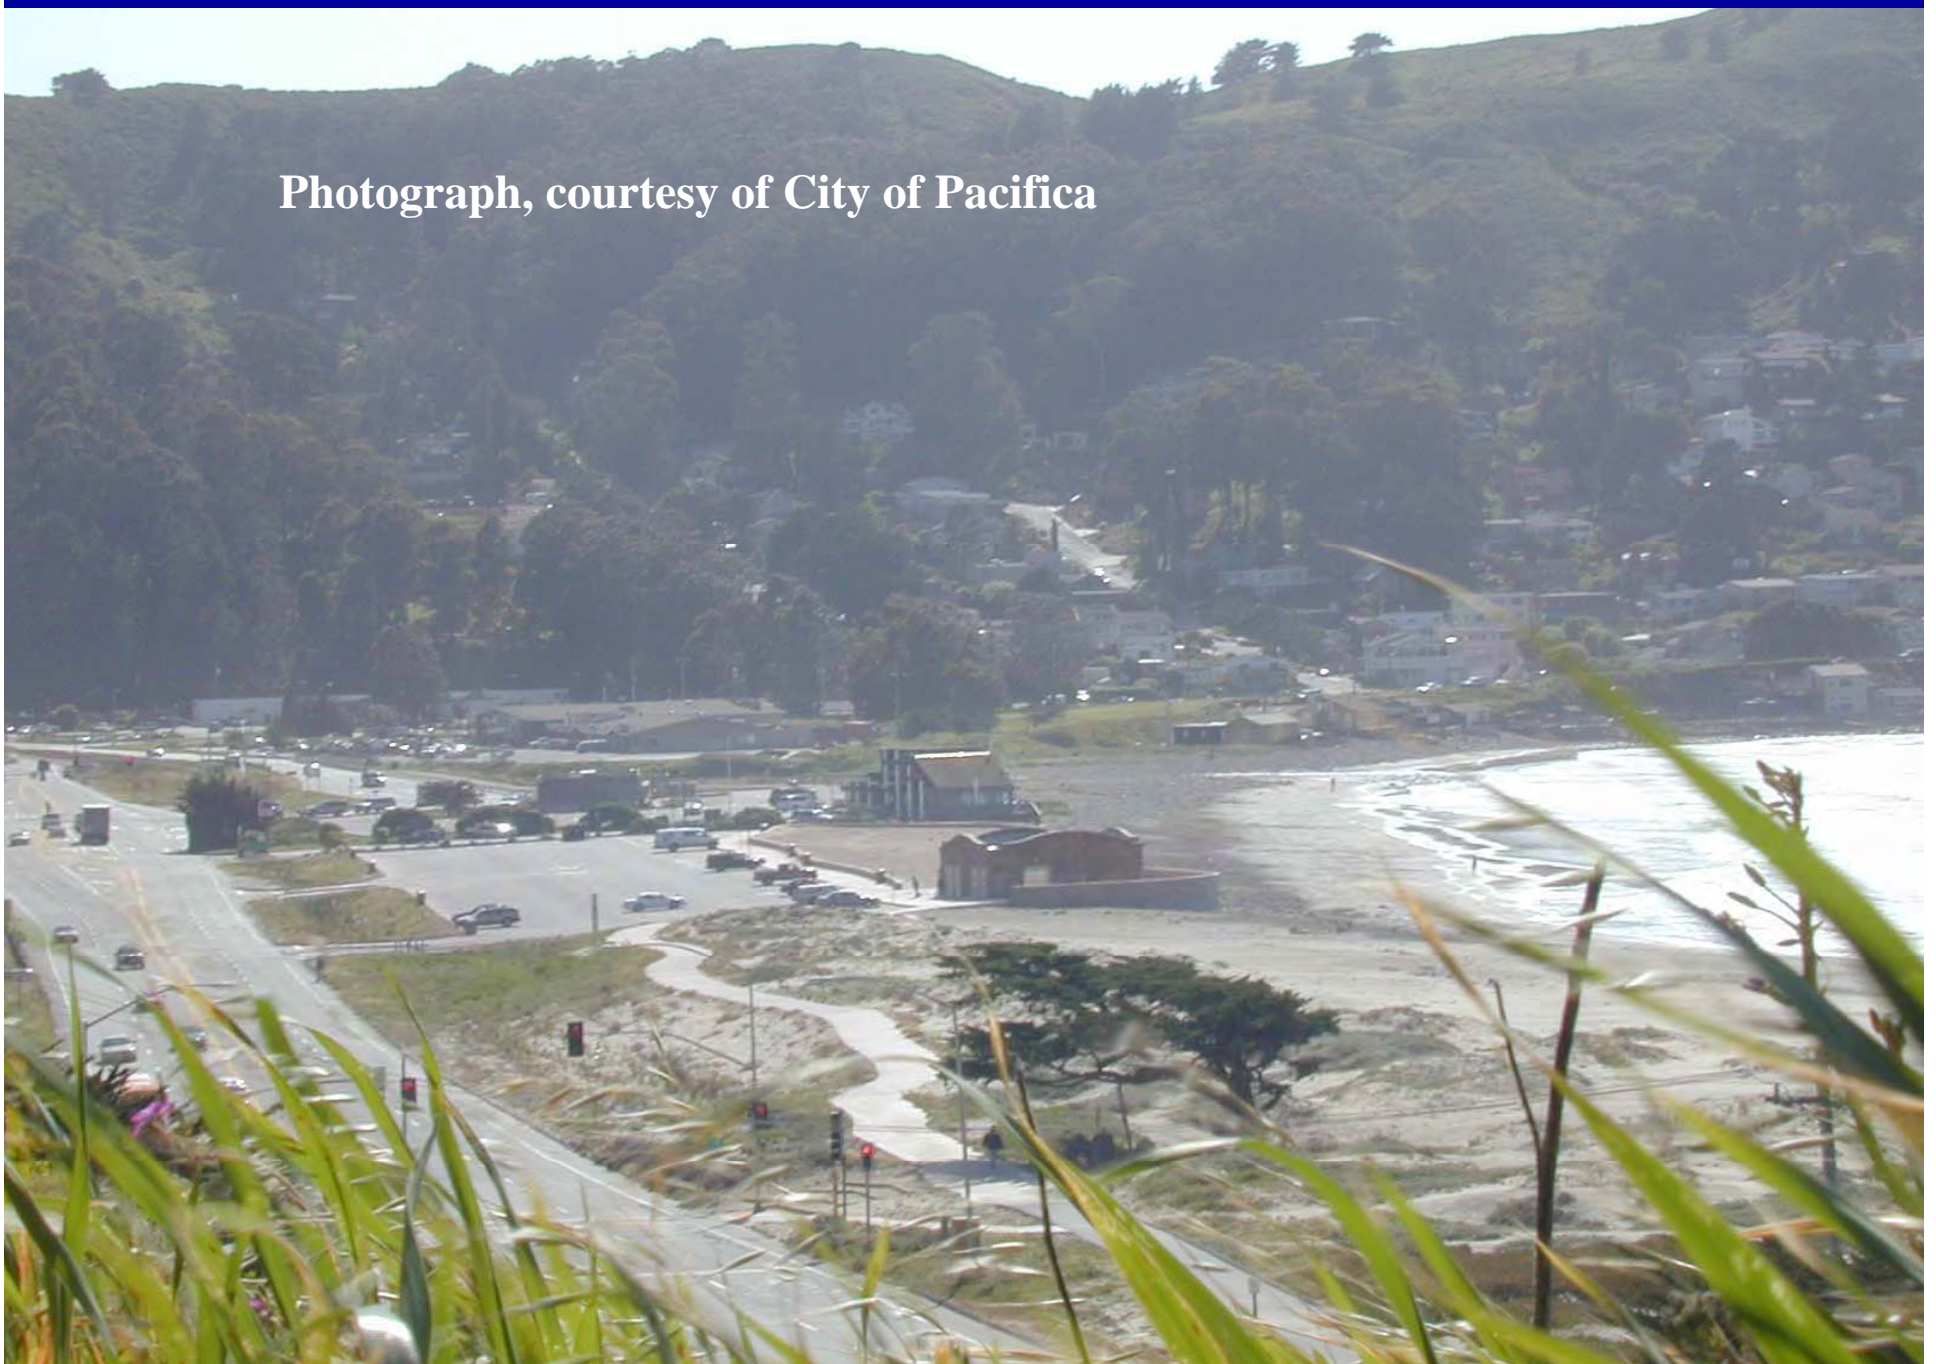
1. Pacifica State Beach, April 15, 2005, Post Construction of Managed Retreat Project
